watsons

Building Survey

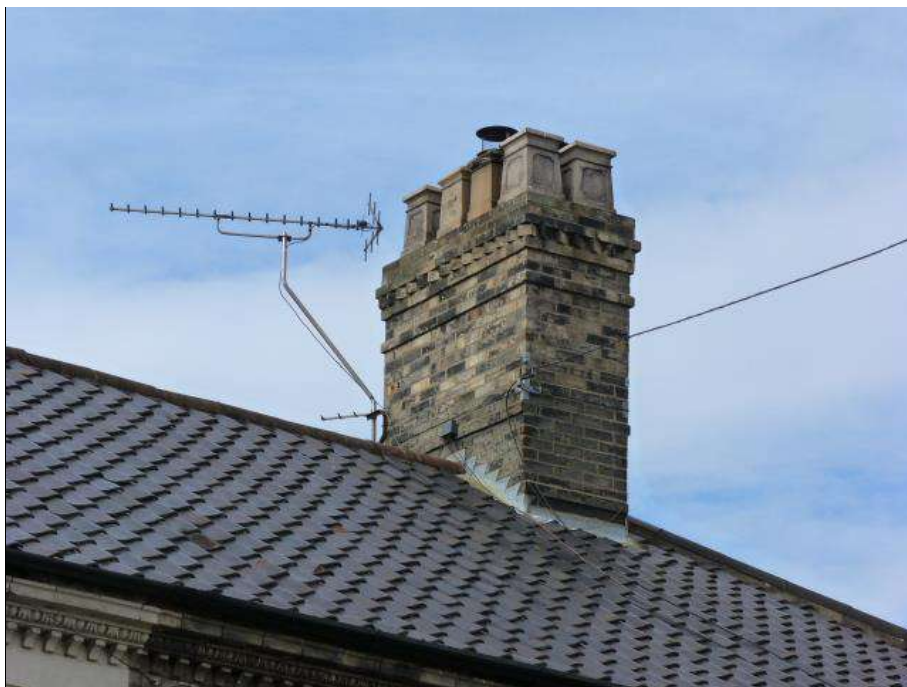
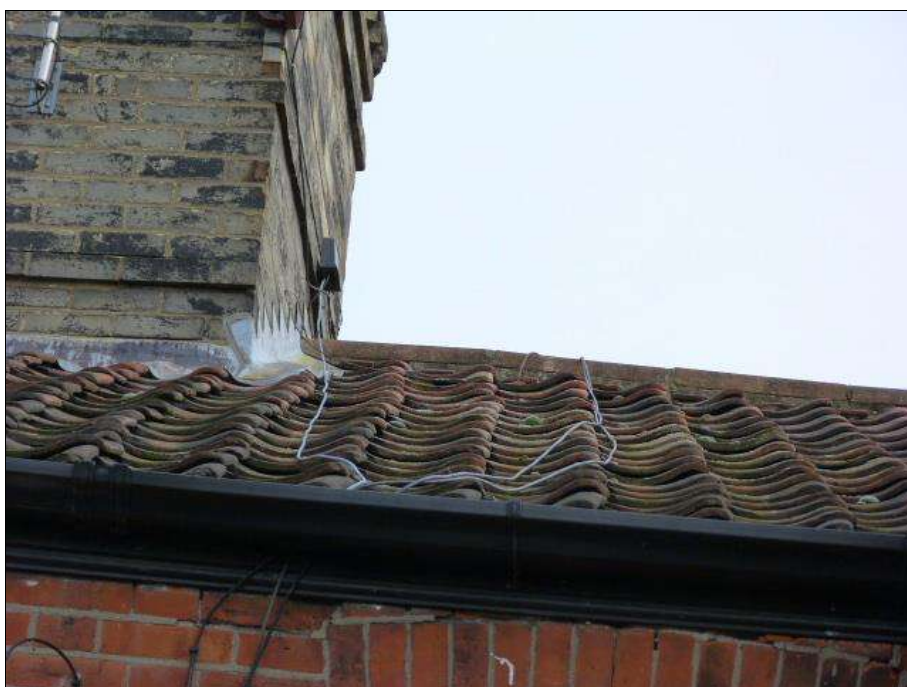
Roof surfaces to the front are covered with glazed pantiles whilst to the rear there are more traditional clay pantiles.

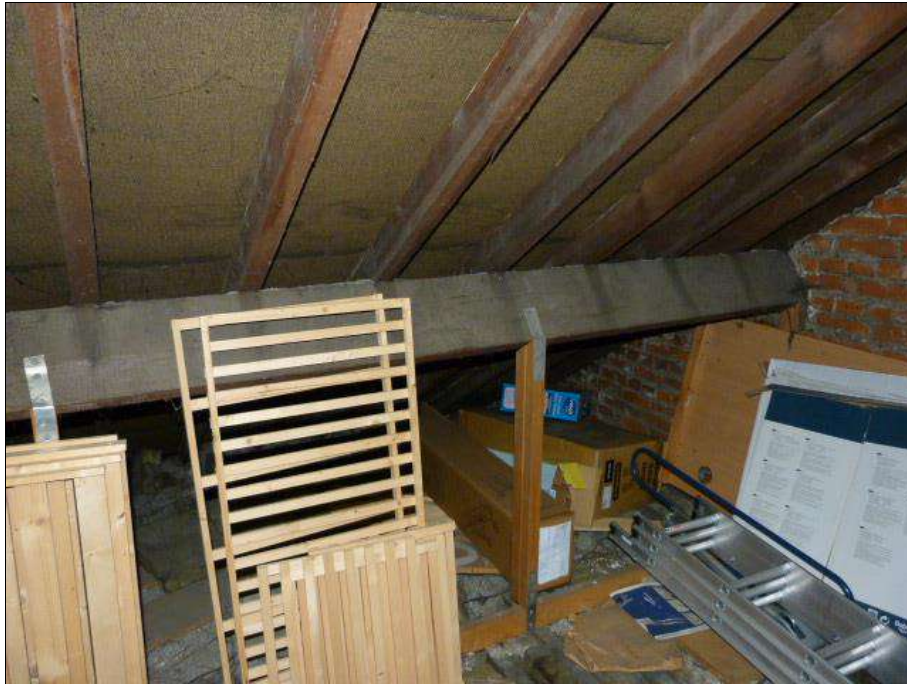
The roof space was inspected, and the structure can be confirmed as comprising traditional cut rafters and purlins. The purlins have been supported by struts which in turn been taken off hangers laid across the ceiling joists. We would suggest this has probably been provided in some attempt to board and line the loft rather than as any substantial support.

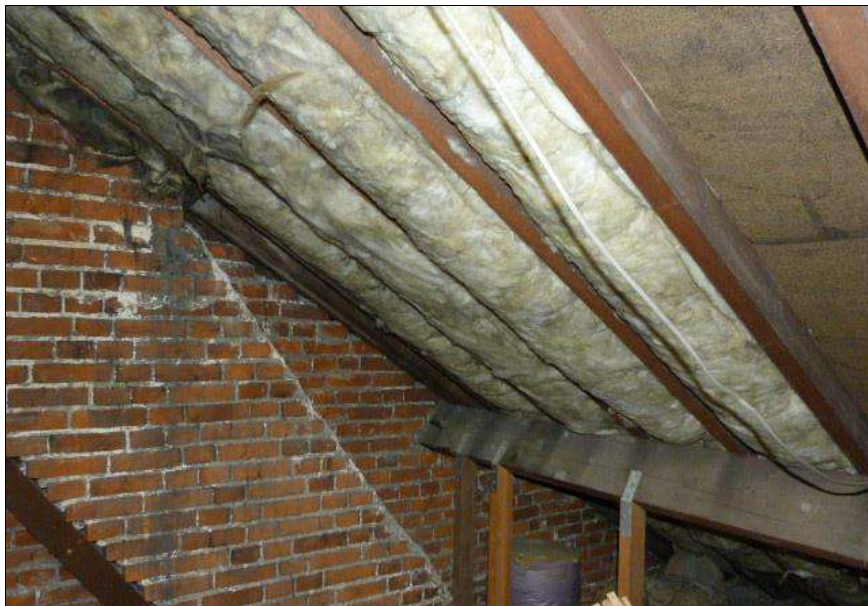
To the underside of the tiles there is a felt underlay. In a section of this there is insulation present for some reason. However, this is limited to the front slope and only four gaps between four rafters.

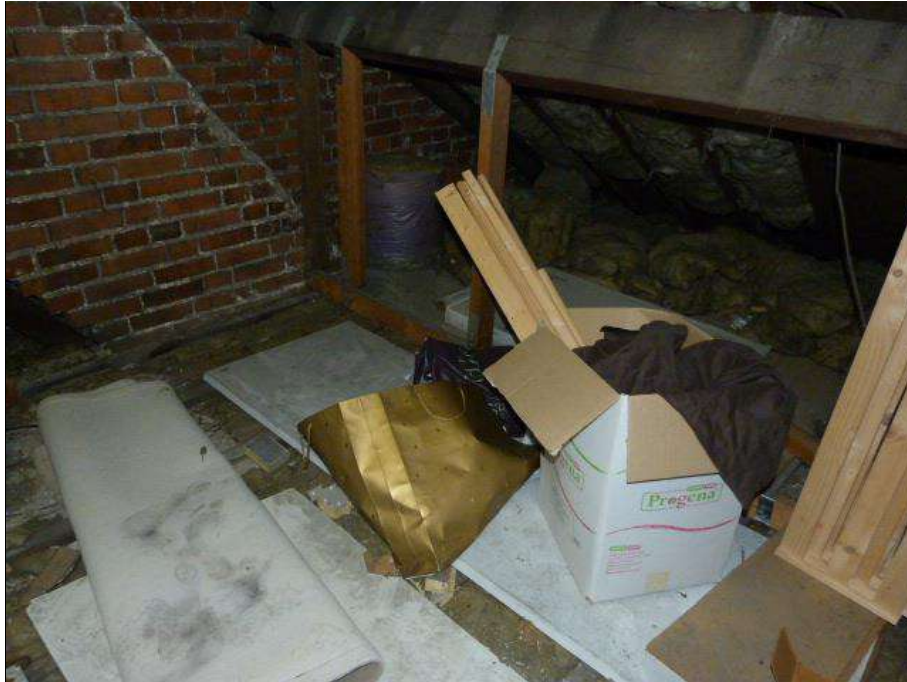
There is some boarding and some stored items within the roof which precluded a more detailed inspection.

There is no formal ventilation and, should you wish to upgrade the levels of insulation within the roof space you would be well advised to consider providing ventilation at eaves level, which will prevent a build-up of moisture and condensation damage to the roof timbers.

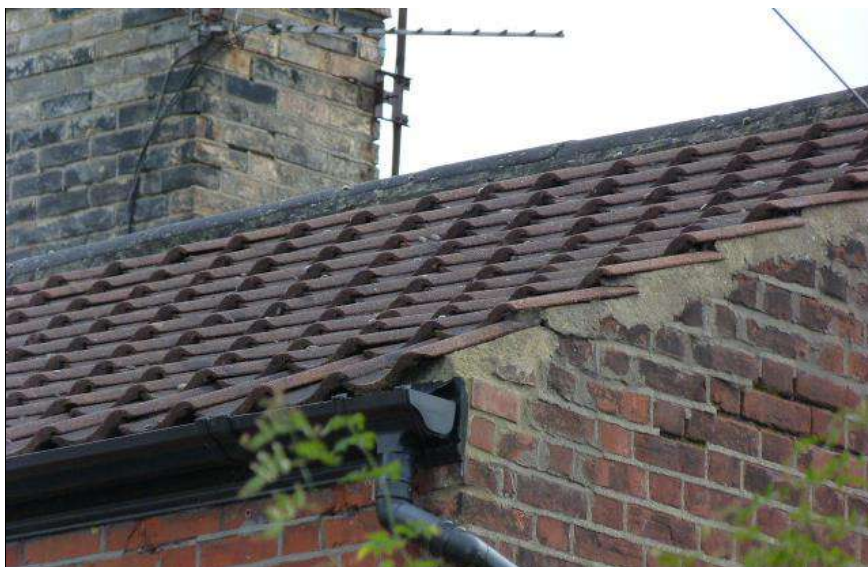
This is pitched and ridged with the main ridge running at right angles to the frontage, draining to gutters at eaves level. Roof surfaces are covered with interlocking concrete tiles. Our inspection of the slope was severely restricted due to the proximity of adjoining dwellings, however from distance the tiles appeared sound with no obvious signs of defect.

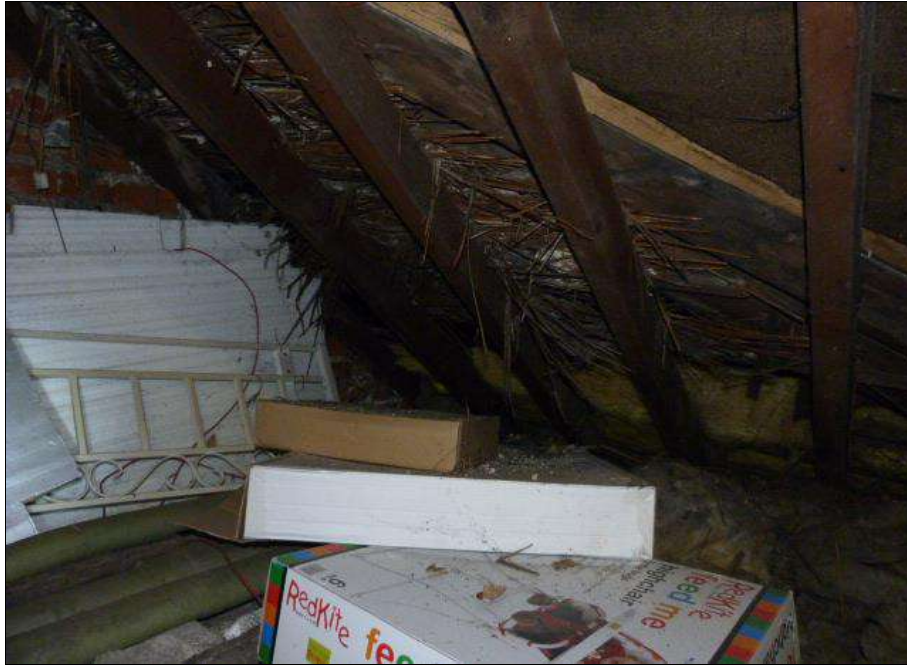
3.2.2 Roof Space

The roof space could not be fully inspected as there was no access hatch and the section between the rear slope of the main roof and the rear roof slope was partially hidden. We were able to inspect a small section, sufficient for us to confirm that there would appear to be no party wall between this and the adjoining property. This is a matter that should be rectified.

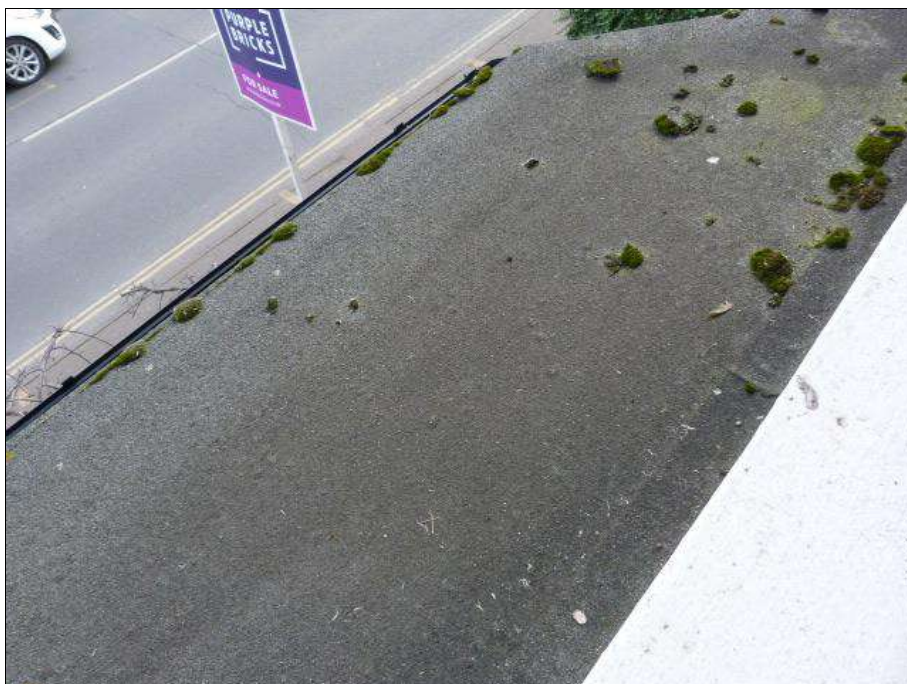
3.2.3 Bay Projection

This is the front bay projection which is subject to a mineral felt covering. It should be appreciated that mineral felt does not have an unlimited life and that repair and/or re-covering should not be unexpected.

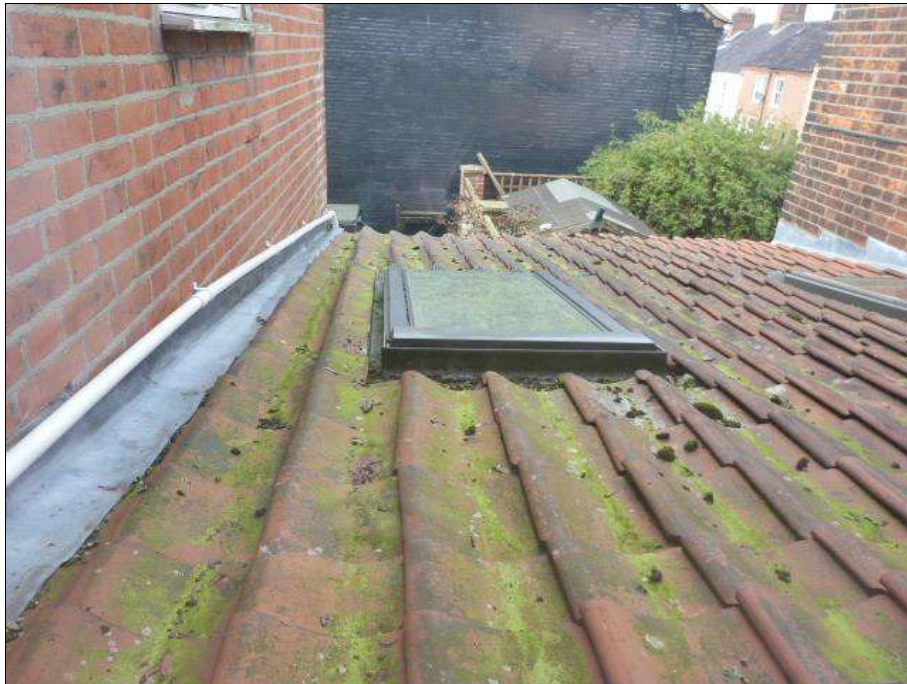
3.2.4 Rear Single Storey Lean-to

This is a pitched structure with a covering of pantiles to which our previous comments would again apply.

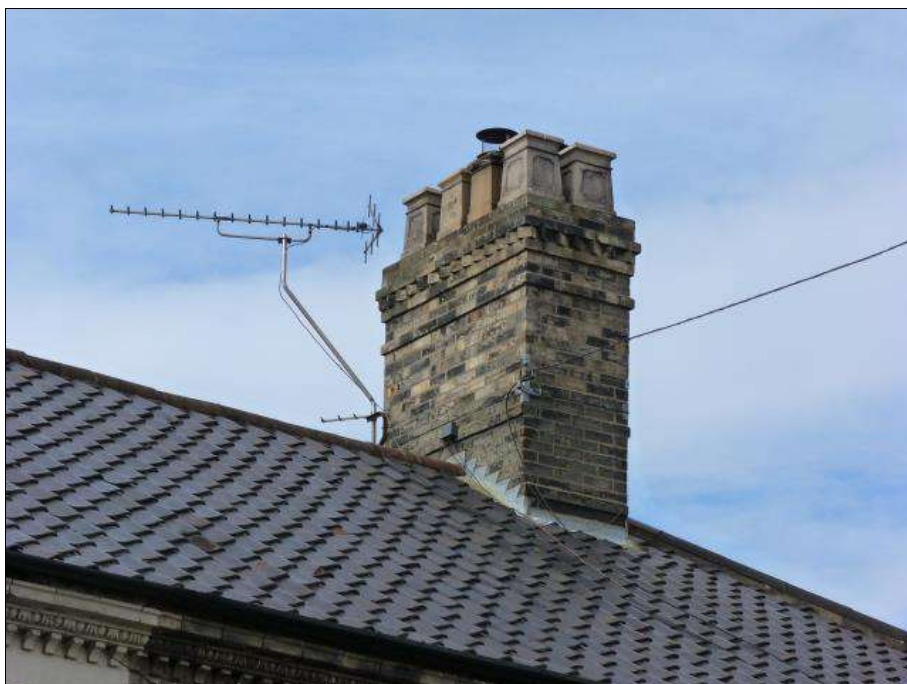
There is a brick-built chimney stack to which both brickwork and pointing appeared basically sound.

At the junction between stack and tiles there is a lead flashing, which also appeared sound.

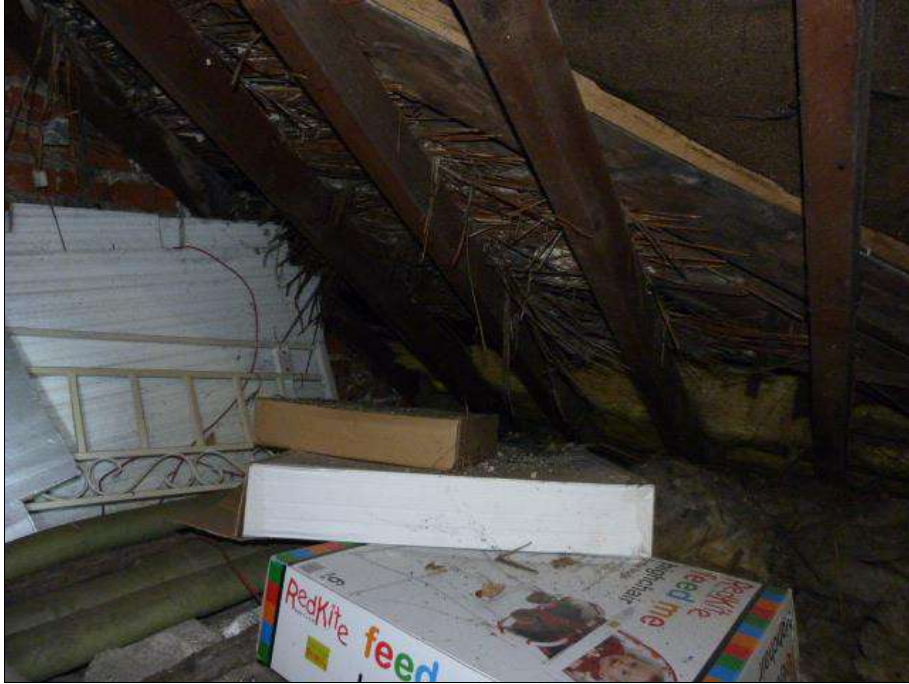
There are no parapets or parapet gutters. There is however a valley gutter formed between the rear slope of the main roof and the rear two storey projection. This could only be inspected from distance sufficient for us to confirm that the valley would appear to be lead lined and apparently sound. Inspection within the roof space did not reveal any signs of water leakage.

It should be appreciated that valley gutters can be a source of weakness. They should be inspected from time to time with the aid of long builders' ladders to ensure the lining material remains sound and there are no blockages.

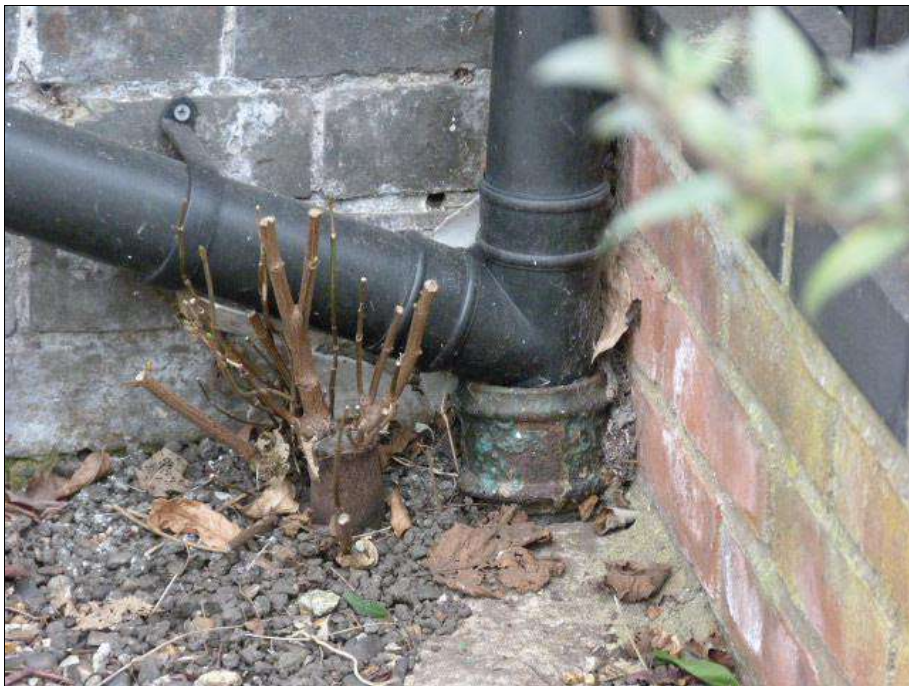
3.5 Gutters and Downpipes

Gutters and fall pipes are of modern PVC construction. Downpipes are connected via closed gullies into what we assume to be a combined foul and surface water drainage system to the rear, whilst to the front we would assume that it drains into the roadway system. Modern PVC gutters serving the front slope and the bay discharge into an original cast iron downpipe at ground level.

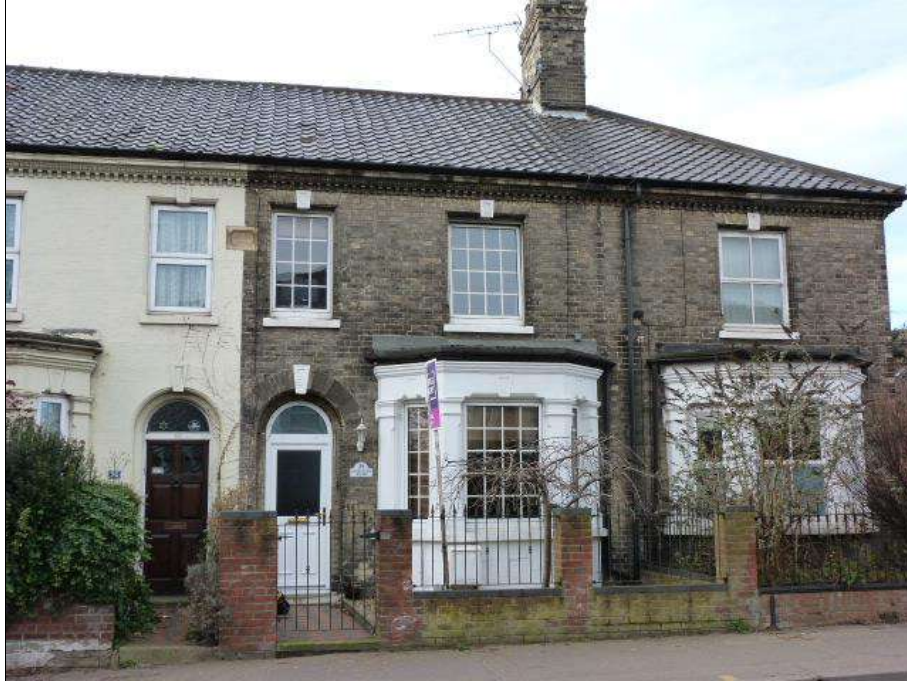
The main external walls of the property were measured on site and found to be approximately 225mm thick overall which would suggest solid construction confirmed to some extent by the external brickwork which has been laid Flemish bond.

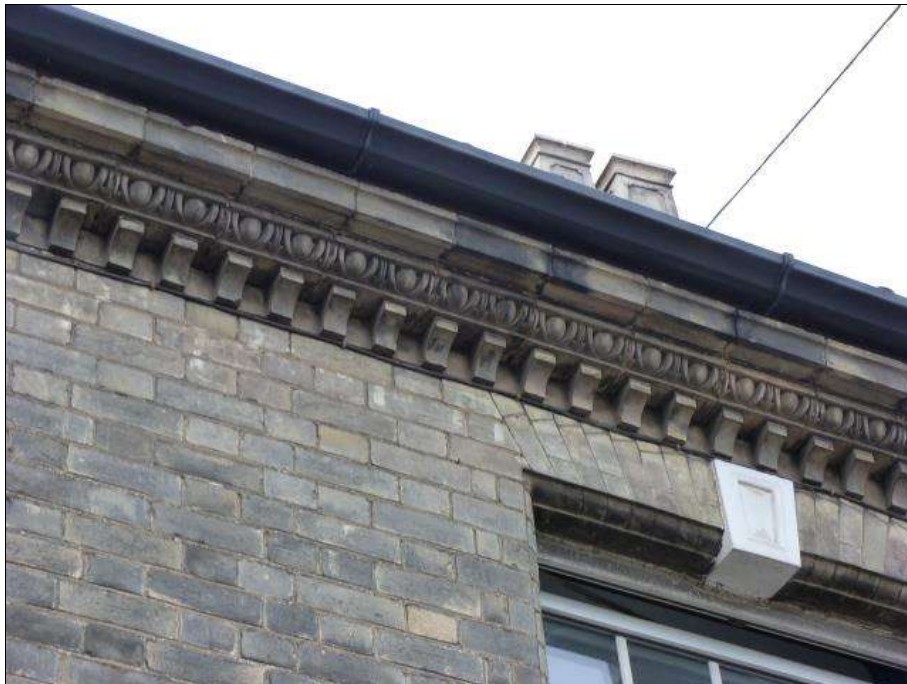
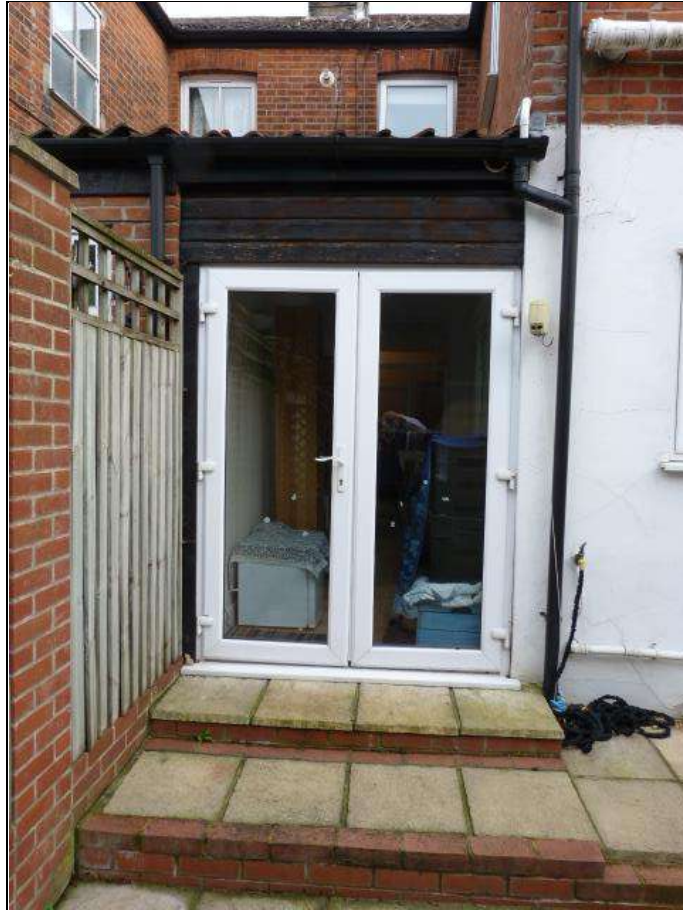
There is an attractive egg and dart moulding to the front of the property at eaves level. The rear elevation at first floor level was visible sufficient to confirm that again this would appear to be of solid brick construction.

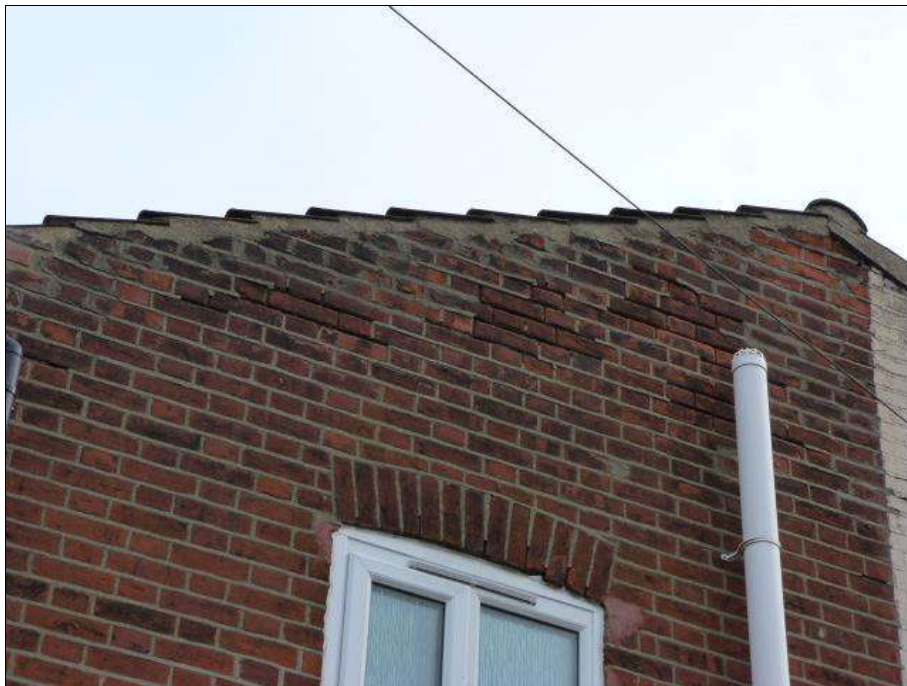
This is a solid structure confirmed to some extent by the brickwork which is again laid Flemish bond. The brickwork has been repointed to certain areas, although a high level of brickwork to the gable requires repointing.

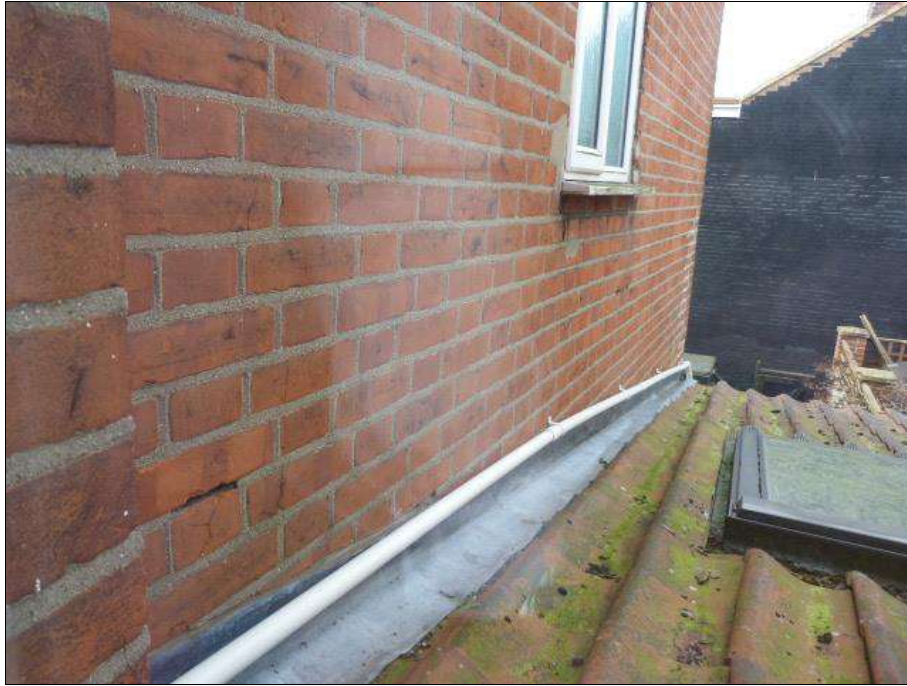
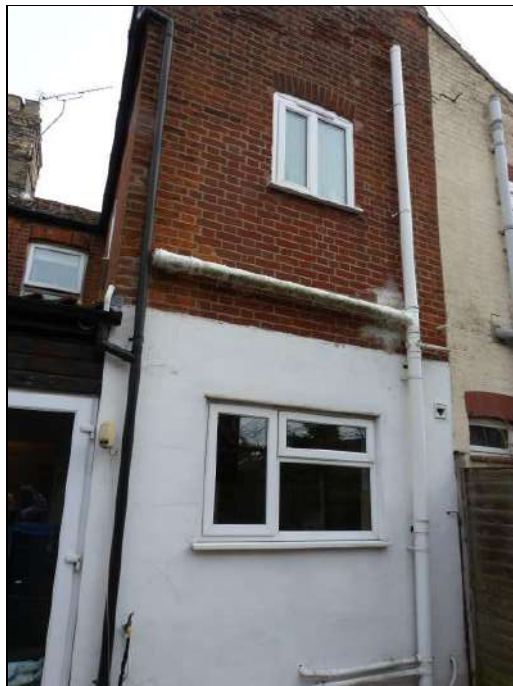
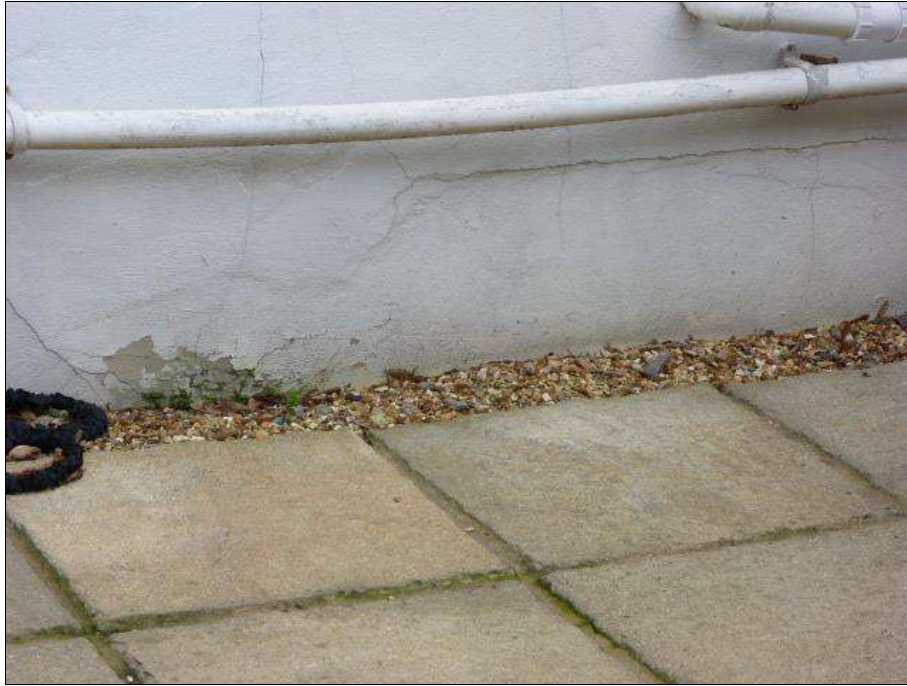
Brickwork to the flank elevation of this two-storey structure again appeared satisfactory. Cement mortar pointing has been used. We would draw your attention to the Lime Appendix at the end of this report.

The rendering at ground floor level is cracked in several places, which might possibly be causing water ingress. It has also been continued down to ground level, which is not ideal.

The external decorative condition of the property would appear sound although as mentioned in a previous paragraph, the external rendering to the rear is cracked and we would suggest that this will require some remedial attention.

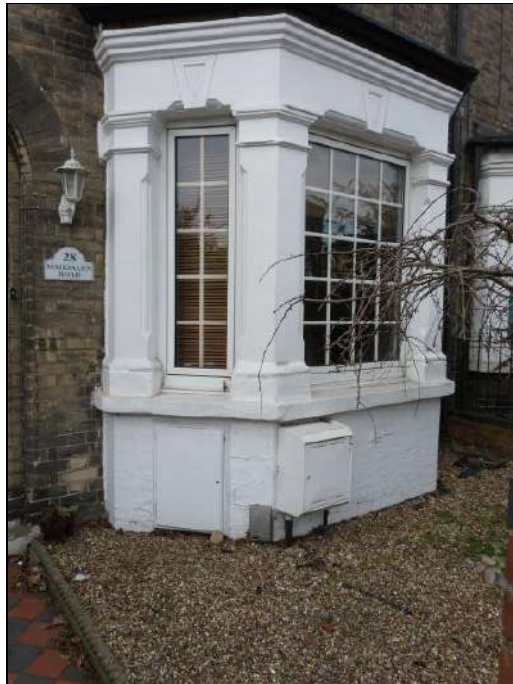
3.7.2 Bay Projection

This is a solid structure which is rendered and colourwashed. This appeared to be in generally satisfactory condition.

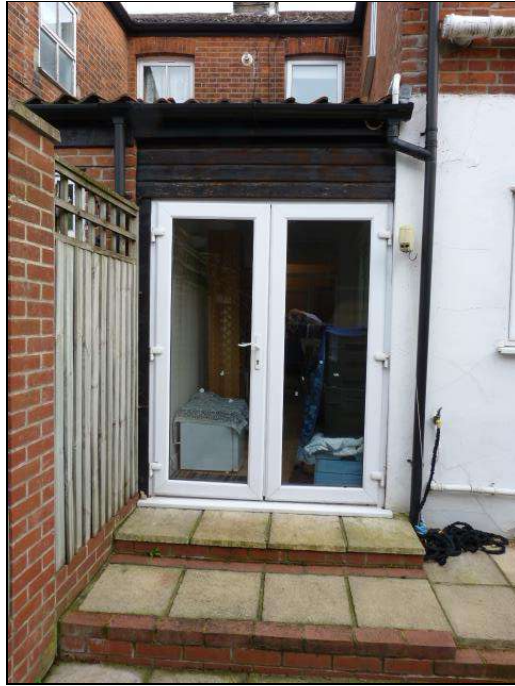
3.7.3 Lean-to Infill

This is the single storey structure to the side of the two-storey projection. This has been weatherboard clad externally. We would suggest that the party wall between this and the adjoining property has been used by the adjoining property for their extension and has been similarly used by this property but has simply been dry lined internally.

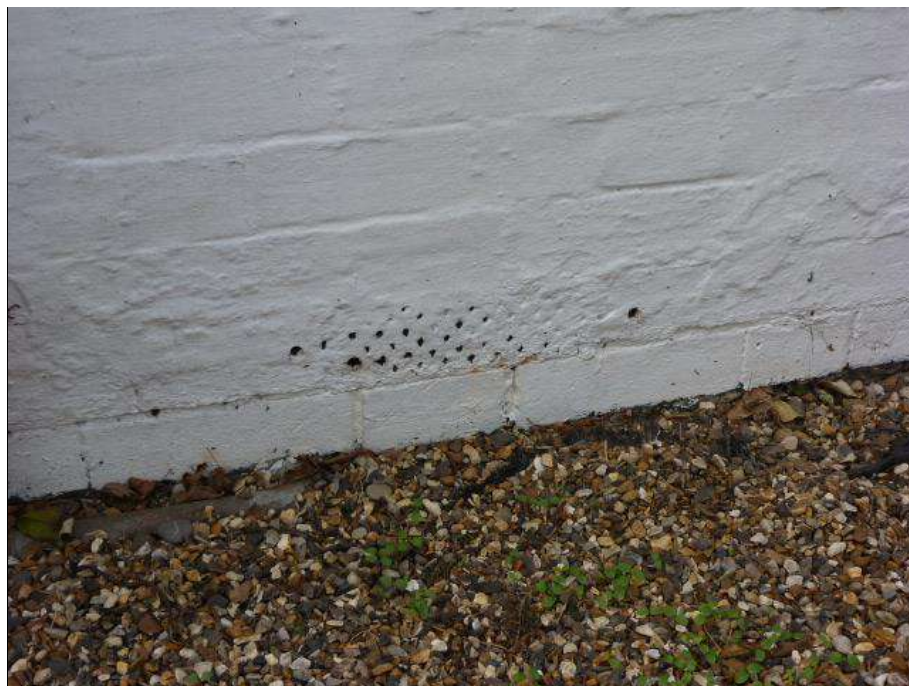
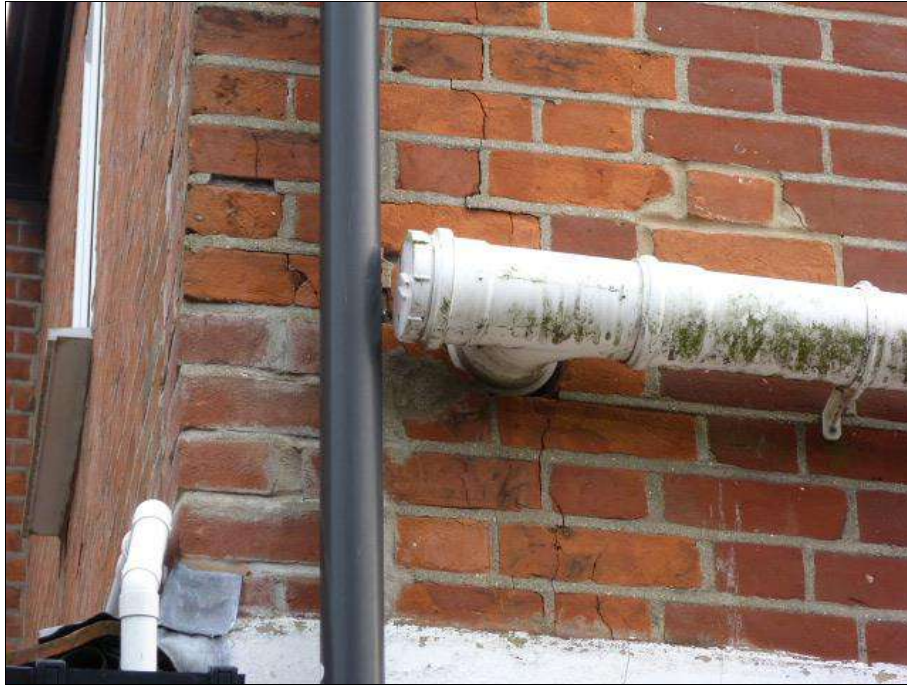
Air bricks have been provided to the front elevation, to the bay, and there is also an air brick within the single storey lean-to projection. It is important to maintain an adequate flow of air beneath the suspended timber floors to prevent build-up of stagnant pockets of air.

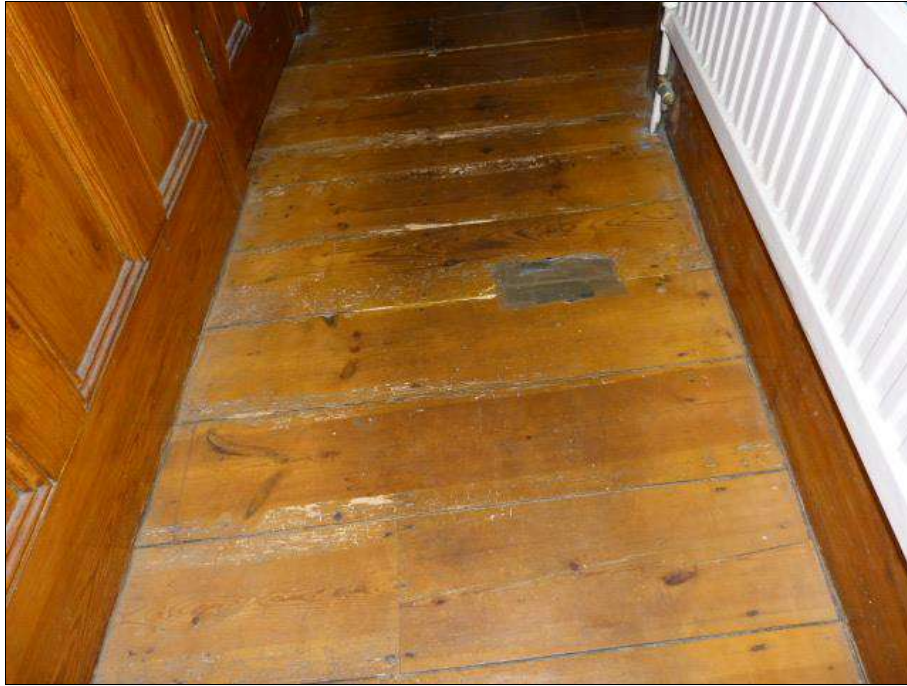
There is no evidence of active woodworm infestation at the time of our inspection. However, it is obvious that some of the floorboards at ground floor level, particularly to the entrance hall, have been badly affected, to the point at which some have been crudely repaired with duct tape.

The condition of these boards is a little concerning and it may be necessary to make provision to replace some of the badly affected boards.

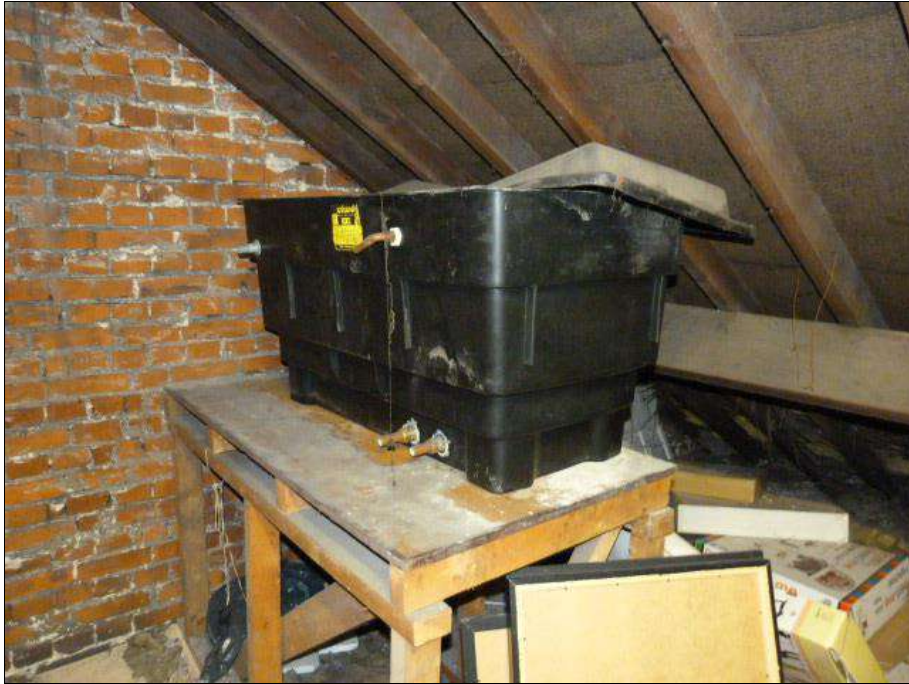
There are no tanks or pipework within the roof space, other than a disused tank.

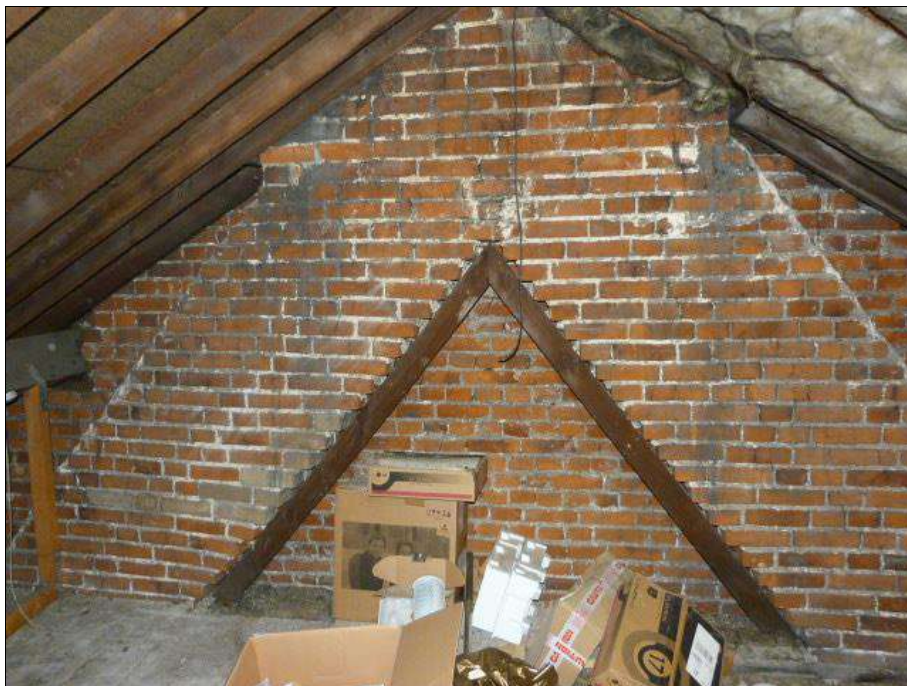
There is a chimney stack visible within the roof space appeared sound with no obvious signs of defects apparent.

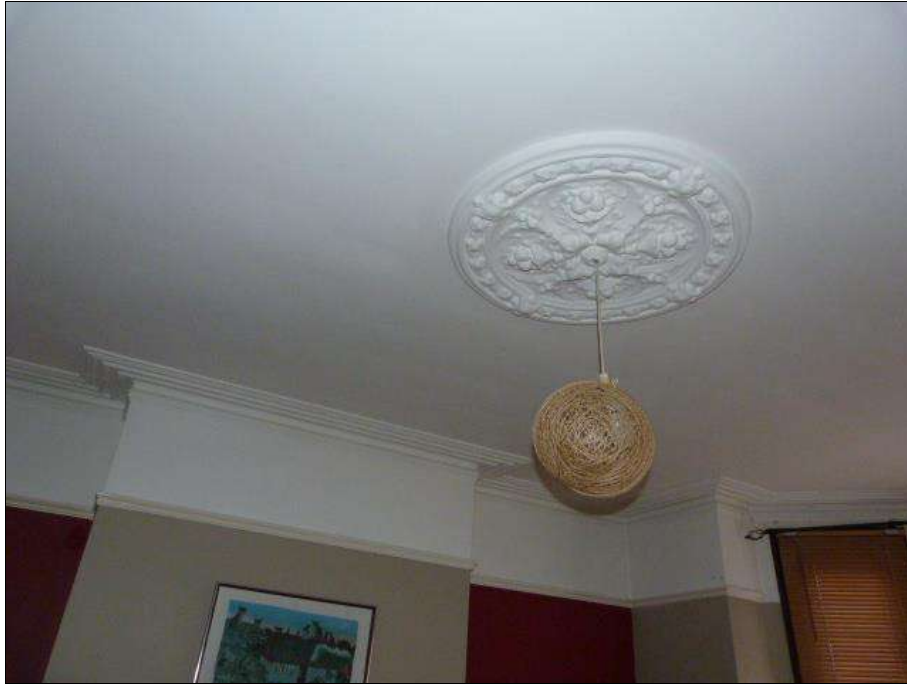
Ceilings, we assume, are a mix of lath and plaster and plasterboard. We noticed some cracking to ceilings in the two reception rooms. However, there is also some ornate ceiling moulding.

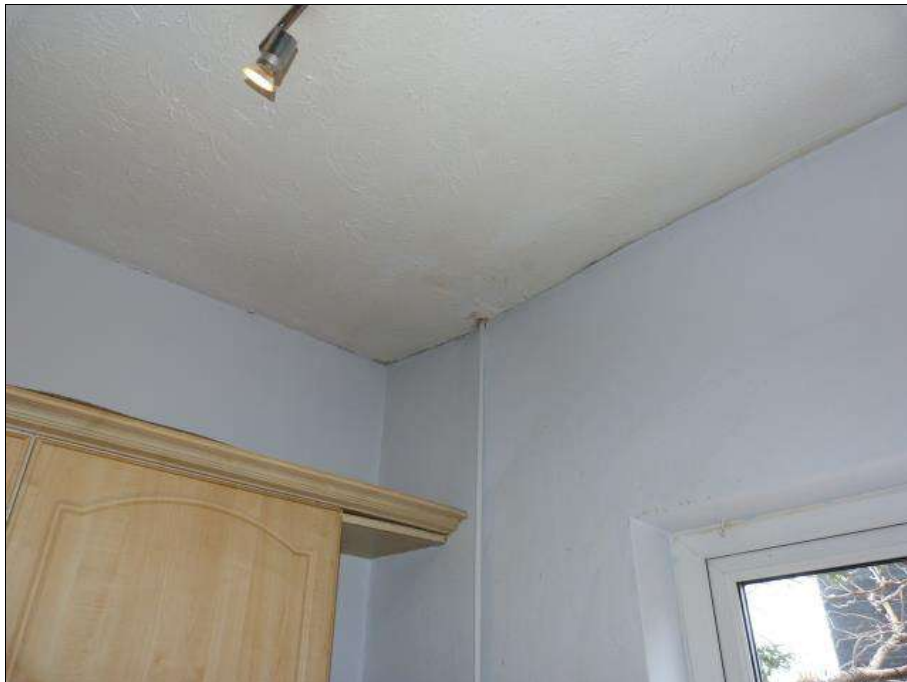
There would appear to be some distortion to the ceiling in the kitchen, beneath the shower unit. We were unable to test for damp, but this might be an area where there has been, or is, some water leakage from the shower above. We would suggest that this matter be further investigated.

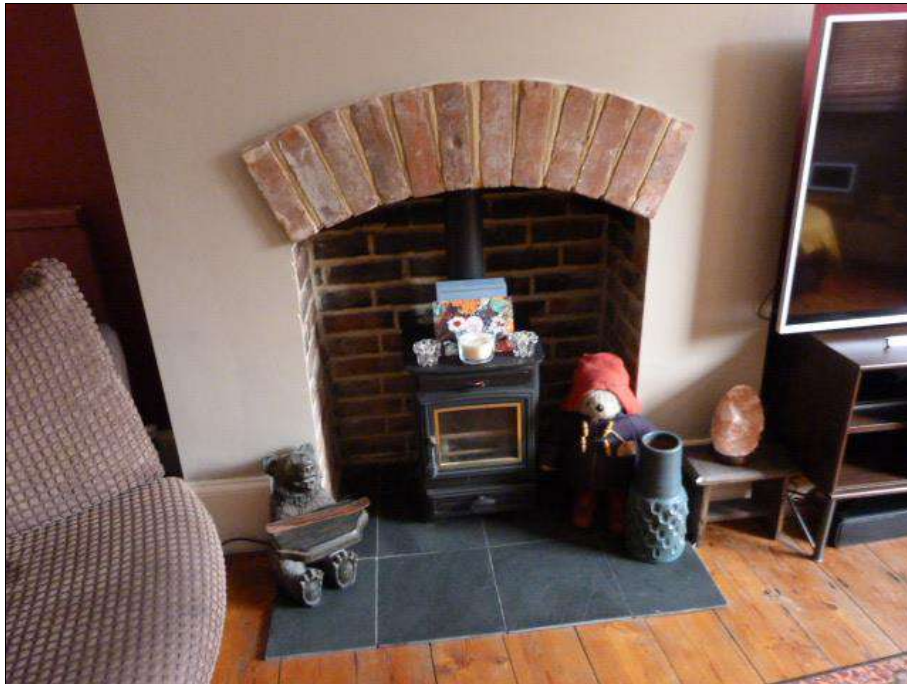
There is a fireplace in the sitting room which has a wood burning stove fitted. No doubt confirmation can be sought as to whether this was installed by a HETAS registered engineer and is therefore compliant.

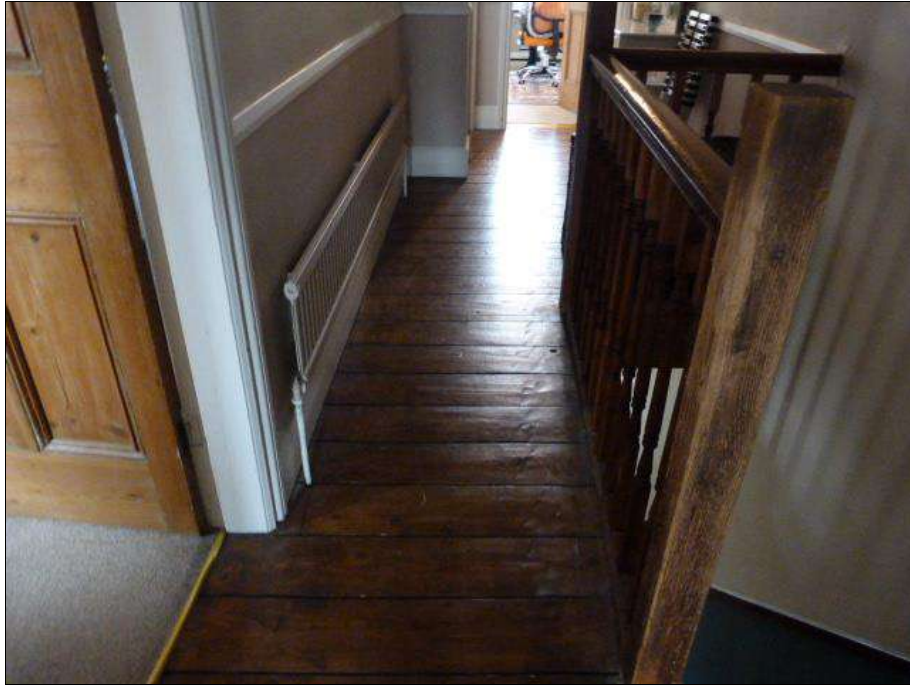
Where tested, floors appeared firm with no evidence of any undue deflection. To the two main bedrooms and the landing the boards were visible at first floor level.

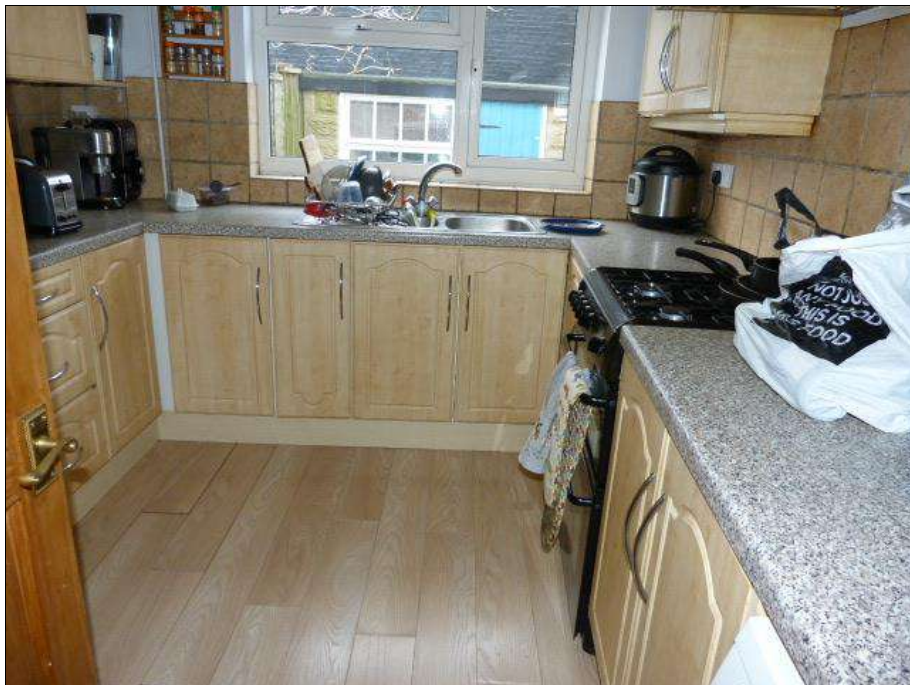
The kitchen has a range of modern units which would also appear relatively sound.

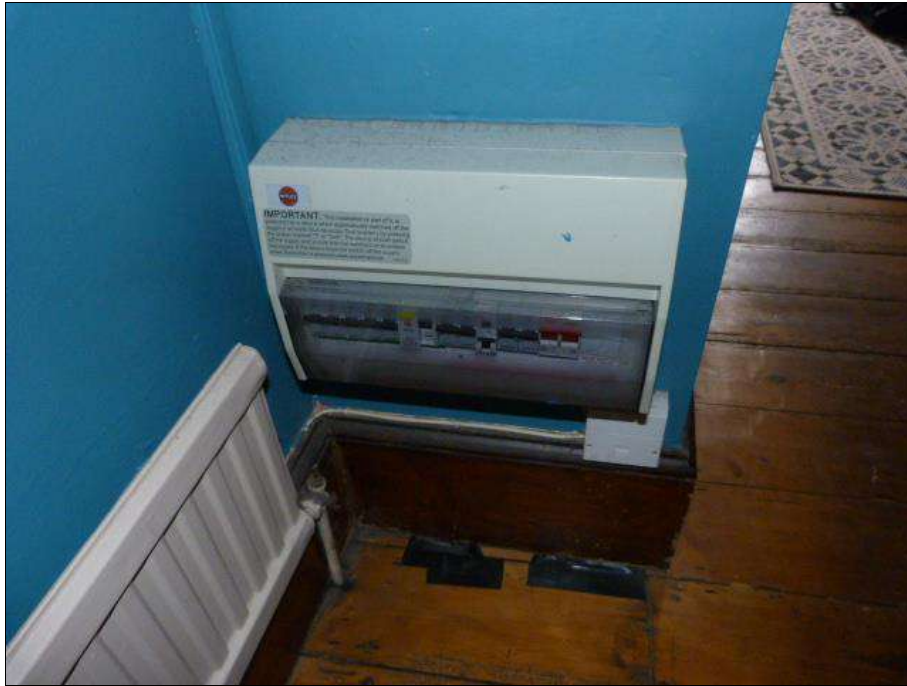
Main's electricity is connected. Wiring and fittings appeared modern. However, it is always a wise precaution to have wiring tested as standards are regularly improved so that even quite recent wiring can be found to need ideal improvement. It is now recommended that all residential installations are inspected and tested on a five-yearly basis by a NIC/EIC or NAPIT registered electrician and a certificate issued on completion. Such a test may well reveal the need for some expenditure.

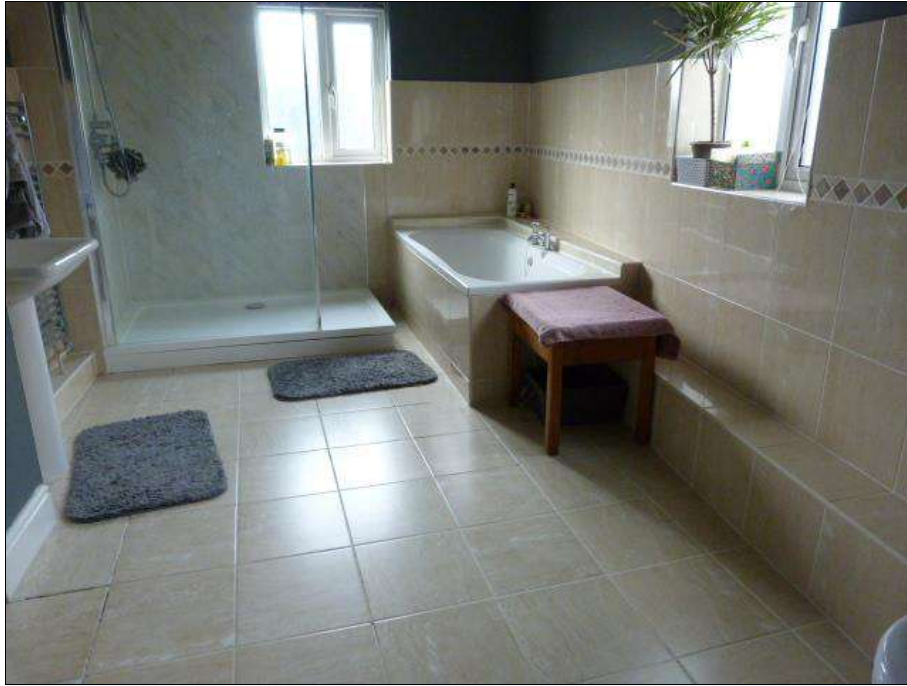
The sanitary fittings to the bathroom would appear to be of a reasonable quality.

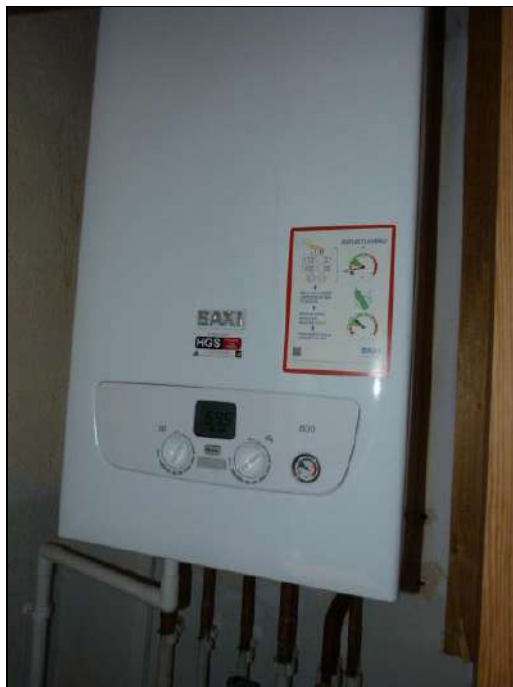
Domestic hot water and central heating are provided by the gas boiler located in the cupboard off the second bedroom.

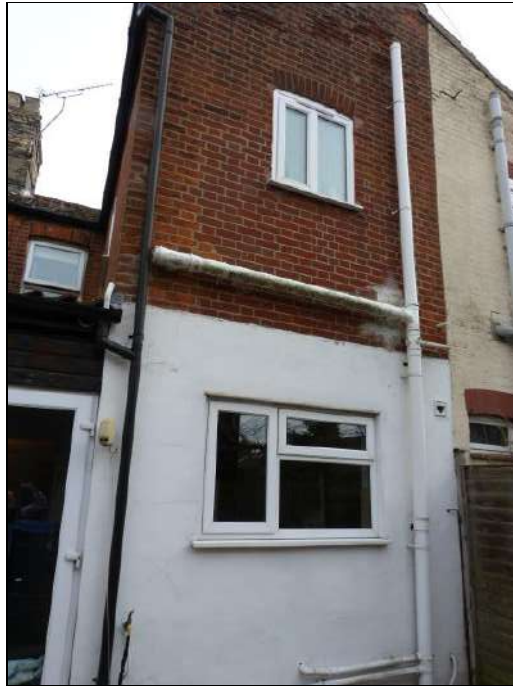
The property is connected to, we assume, the mains sewer. However, there were no inspection chambers located on site and we are therefore unable to report on any detail upon the condition of the underground drains. Above ground there are modern PVC soil and vent pipes.
