watsons

Building Survey

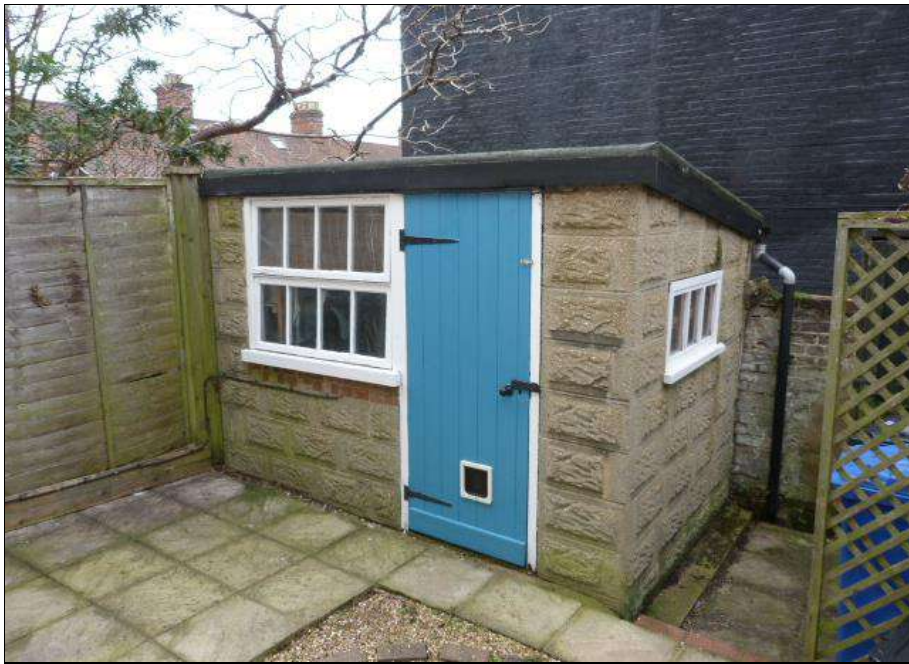
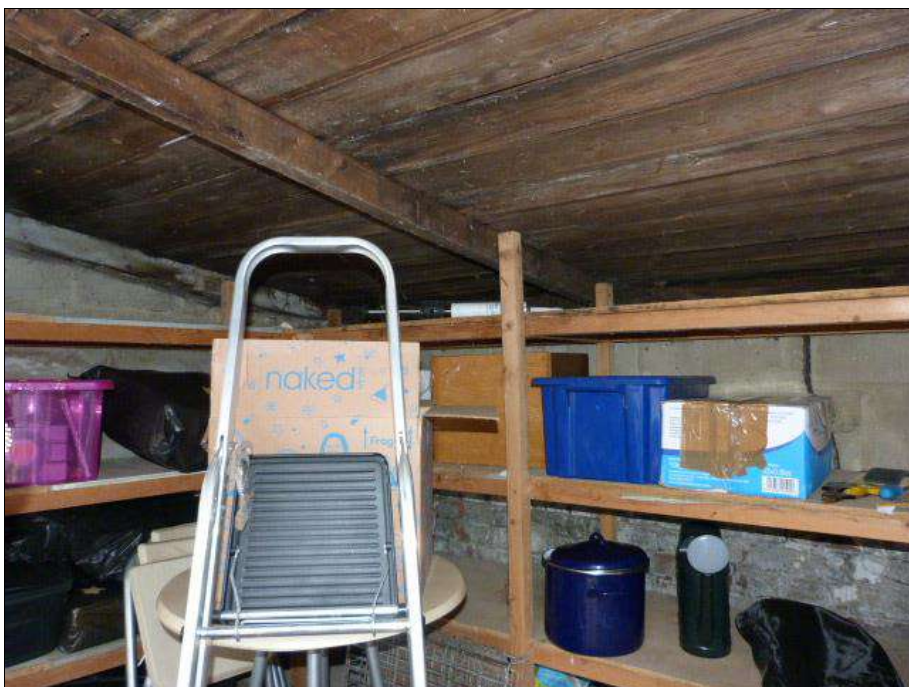
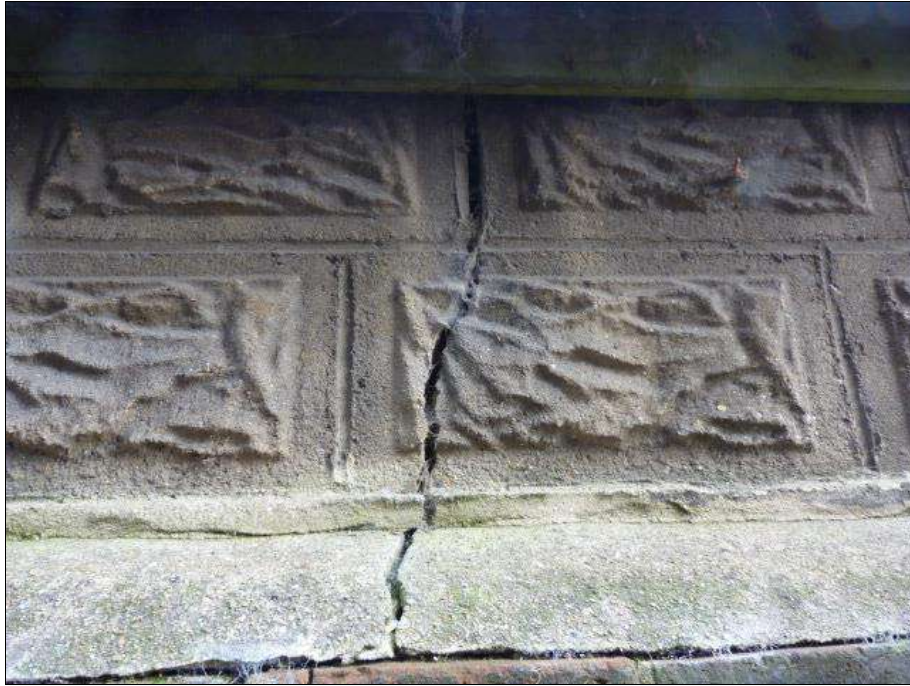
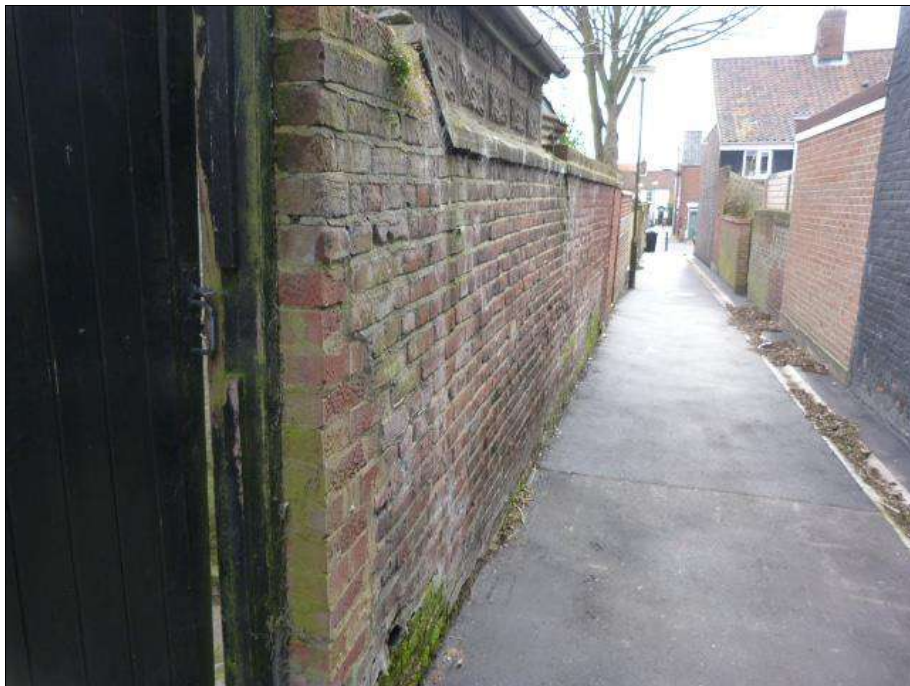
There is a concrete block store shed to the rear. It has a mineral felt, gently sloping roof. There is evidence of quite substantial cracking internally to the rear wall, which is also visible in part externally. The wall generally along this rear elevation has bowed and is leaning inwards.
