watsons

LEVEL 2

# Your survey report

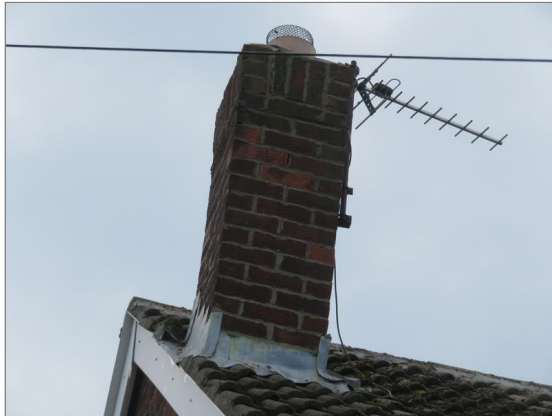
From ground level it was not possible to see the condition of the flaunching, the area into which the chimney pots are set. The chimney appears to require a general programme of maintenance including repairs to the spalled and mortar jointing. This should be carried out soon.

Some parts of the chimney are not visible or only partly visible from the ground and hidden defects may be present, for example to the flaunching and back gutter area. When safe access is possible to these areas, it would be advisable to carry out a closer inspection to check they are in an acceptable condition.

*Photo - 2 Chimney*

Because of the location, height or position of the chimney, scaffolding or other means of safe access will be required to carry out repairs which will increase costs significantly and you should budget accordingly. Permission may also be needed from the neighbour to undertake these works.

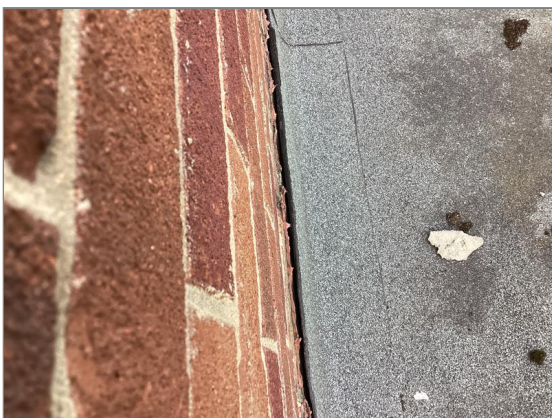
The flashing between the front flat roof covering and the adjacent wall has shrunk away from the wall and is poorly secured. Some repairs to the flashing may involve disturbing the roof covering. This could lead to water ingress and should be repaired soon. No evidence of water ingress was noted at the time of our inspection however our inspection followed a period of dry weather and it was noted that recent redecoration has been carried out. Given the age of the covering, it may be more economical to replace the whole of the roof covering as well. This is a risk to the building:

- defective flashings.

*Photo - 3 Front flat roof flashing junction (from above)*

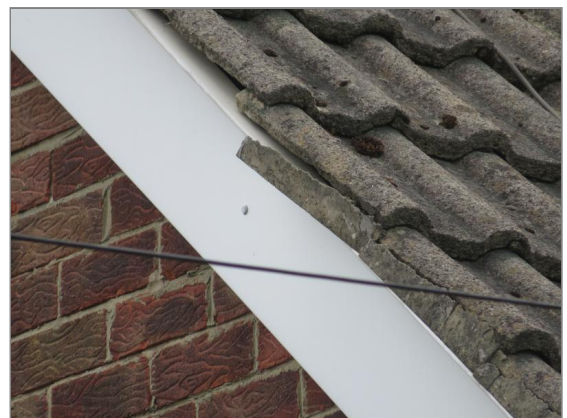
The mortar work below some verge tiles was noted to be missing, cracked and defective requiring raking out and renewal. Raking out and repointing may prove a short-term solution and it is likely to fail again. Ideally, the verge tiles should be lifted, the defective mortar renewed and the tiles re-bedded. This should be carried out by a competent roofing contractor.

*Photo - 4 Verge mortar*

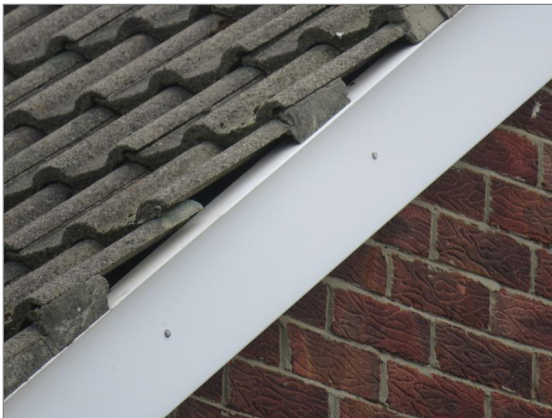
*Photo - 5 Verge mortar*

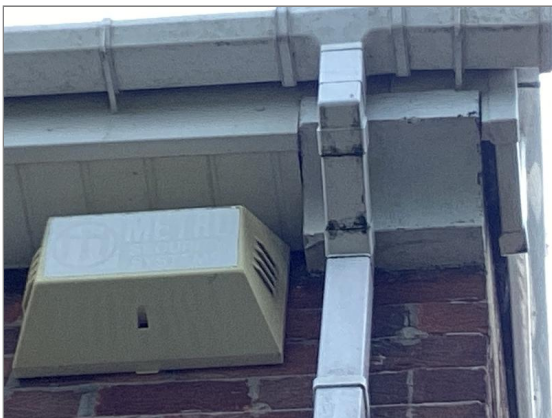
Staining was noted to some gutter and down pipe joints suggesting localised leakage. General resealing and realignment of joints should be carried out.

*Photo - 6 Staining to joints*

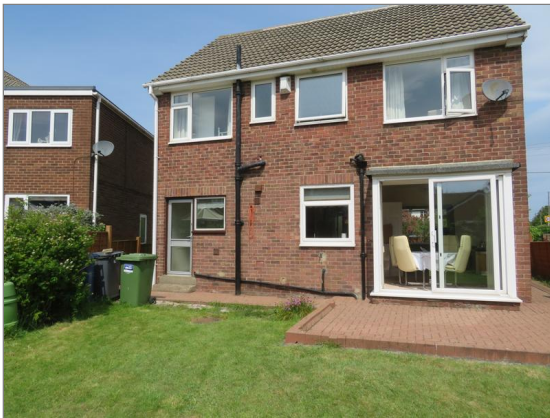
Within the limitations of our inspection, the wall surfaces appeared to be in a generally satisfactory condition and no significant defects were noted. The pointing is generally satisfactory, but there are some loose areas which will require raking out and repointing during routine maintenance using a suitable mortar. We found no signs of significant past or present movement in the external structure of the building, although we would recommend that confirmation is sought from the Vendors as it can be difficult to identify after remedial works have been undertaken. We found no evidence of significant dampness within the scope of our inspection and report.

*Photo - 7 Rear elevation*

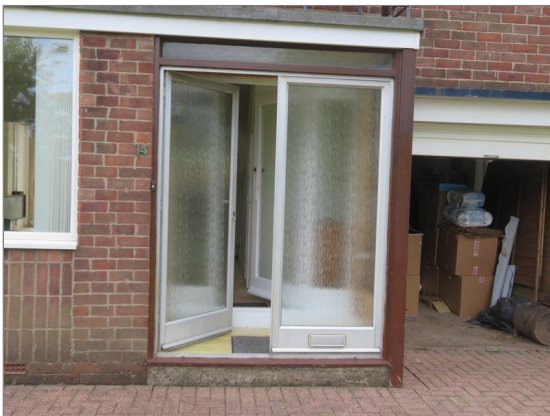
The external front and rear doors are of aluminium construction. The doors are of considerable age and consequently serviceability must be suspect and the need for routine maintenance anticipated until eventually renewed. We would recommend you obtain a quotation for renewal prior to

General deterioration and decay was noted to some areas of the timber doorframes. A comprehensive overhaul of the joinery is now required, complete replacement of at least some sections should be anticipated.

*Photo - 8 Front door*

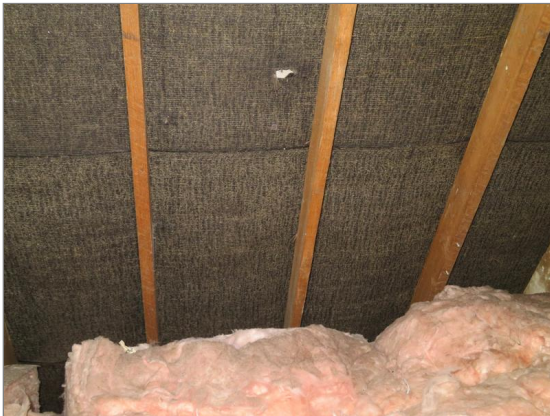
The roof lining is an older type of sarking felt, commonly used in this situation and becomes brittle with age. It has a tendency to rot at the eaves if not properly supported and the rear of the fascia and top side of the soffit boarding will become damp and provide conditions for wet rot to occur. The roofing felt is now deteriorating with several holes present. The material has limited life and will continue to deteriorate. Roofing contractors will often encourage homeowners to have the entire roof covering renewed if the sarking felt under the tiles deteriorates. This is generally unnecessary as it is possible to remove a section of tiles and simply patch the affected felt rather than completely stripping the roof and renewing.

*Photo - 9 Damage to sarking felt*

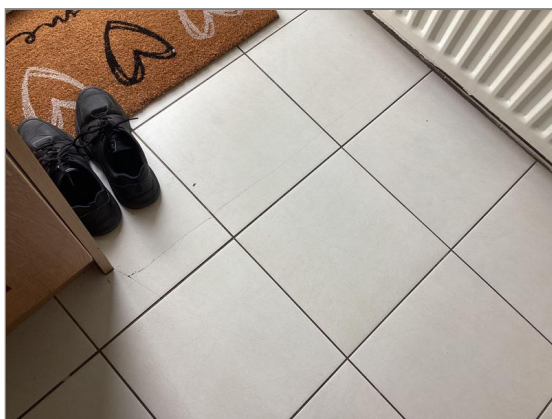
The ceramic tiles in the kitchen have been laid on a timber floor and unless the floor has been prepared correctly these brittle finishes can deform and crack when the floor flexes. Cracking was noted to the tiles. Further cracking may occur in the future. The repairs needed are not serious or urgent and are considered to be part of normal maintenance work of the property and should be dealt with after taking ownership or when annual maintenance is next carried out.

Photo - 10 Cracking to tiles

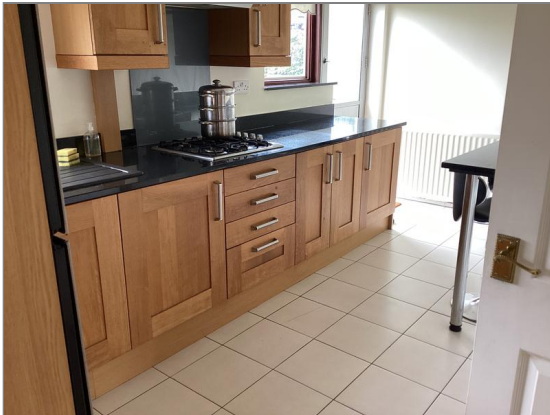
Photo - 11 Kitchen

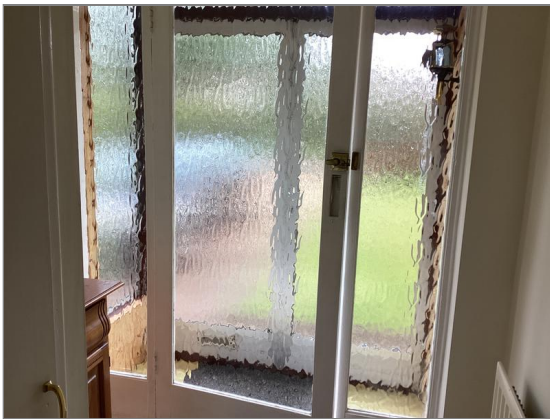
Photo - 12 Internal door

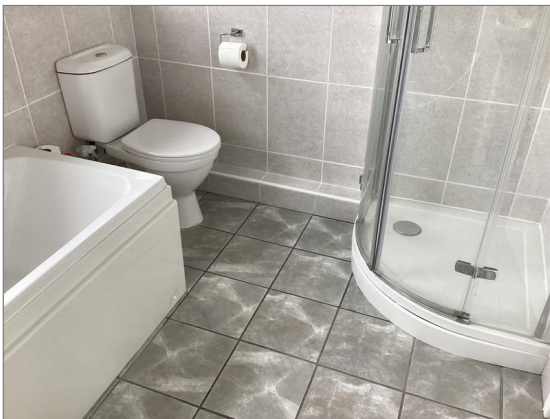
*Photo - 13 Bathroom*

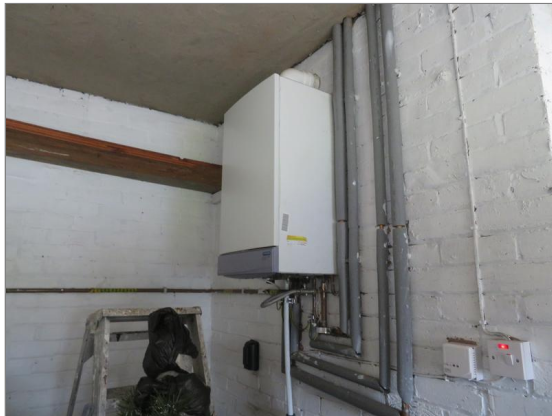
*Photo - 14 Boiler*

If there has been no inspection or test within the last 12 months then an inspection and service/safety test of all heating appliances must be carried out before use.

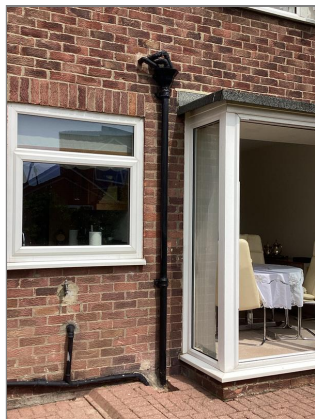
The rear bathroom waste pipes discharge into a cast-iron downpipe which is rusted and of considerable age. You should budget for some repairs and replacements.

*Photo - 15 Rear waste pipe*

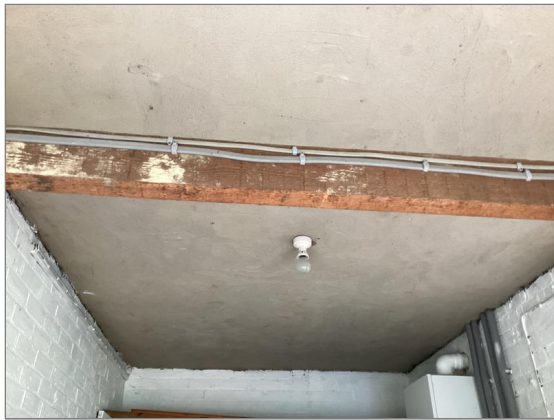
Photo - 16 Garage ceiling

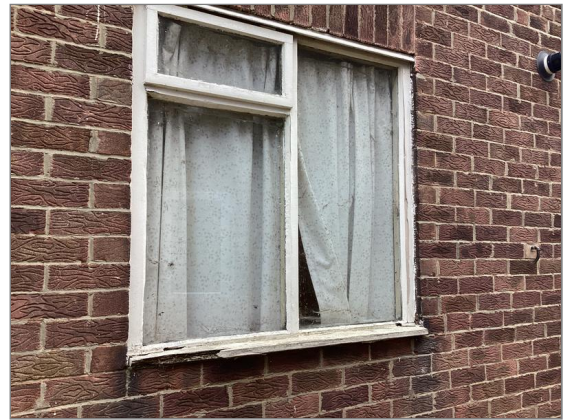
Photo - 17 Garage window

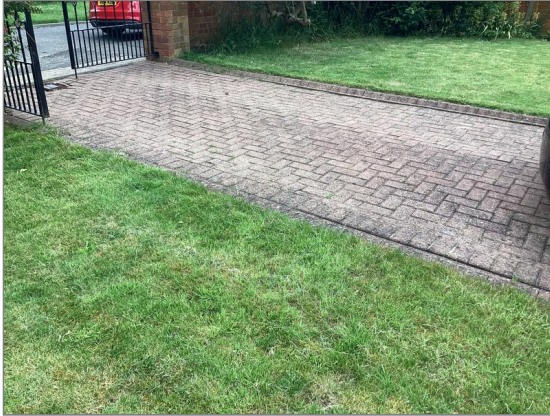
*Photo - 18 Uneven driveway*

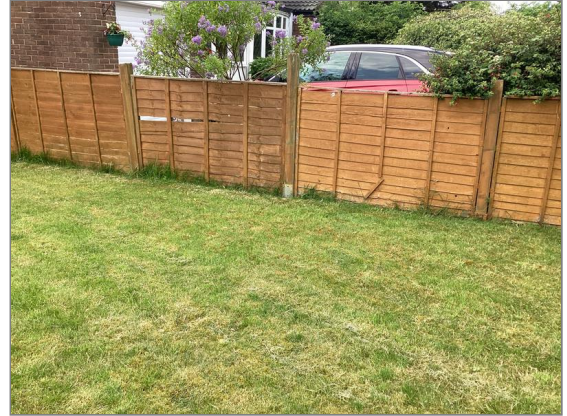
*Photo - 19 Timber fencing*
