LEVEL 3

Your survey report

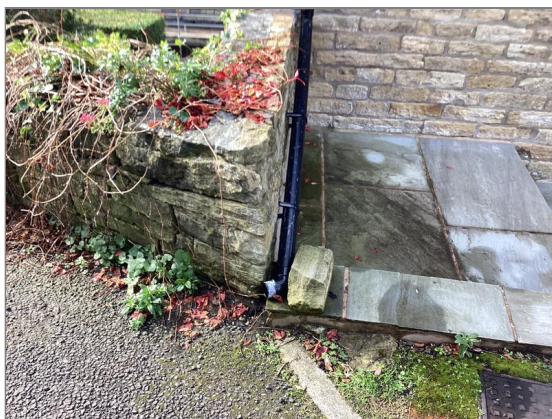
Photo - 2

The rainwater goods should now be water tested in order to establish their current condition and any repairs identified undertaken as soon as possible.

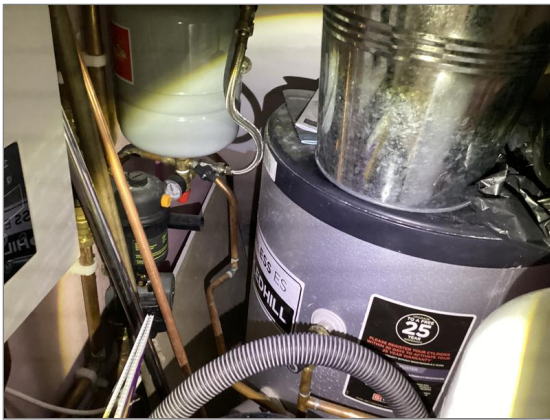
Photo - 17

There is a modern pressurised hot water cylinder located in the wc . We recommend this is tested prior to use and annually thereafter to confirm safe operation.

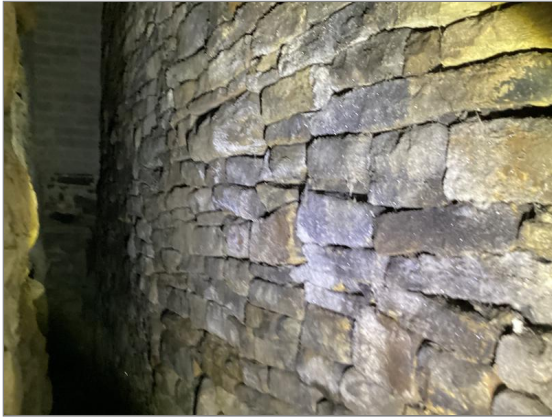
Photo - 10

Some of the walls around the curtilage of the site are substantial retaining structures. Such walls do represent a major repair and financial liability and it is vital that they are inspected on a regular basis and maintained in good condition. Adequate drainage is required for retaining walls and some improvement may be required in the future.
