watsons

LEVEL 2

# Your survey report

1st July 2025

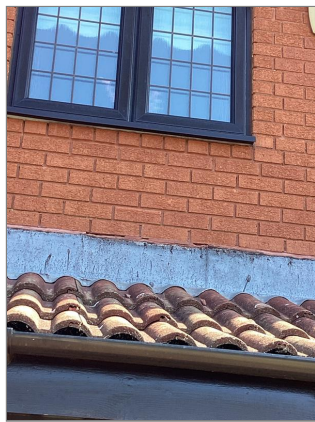
The mortar pointing to the lead flashing where the single storey roof abuts the adjoining wall has come loose. This could lead to water ingress and this should be repointed.

*Photo - 1 Mortar pointing missing to flashing*

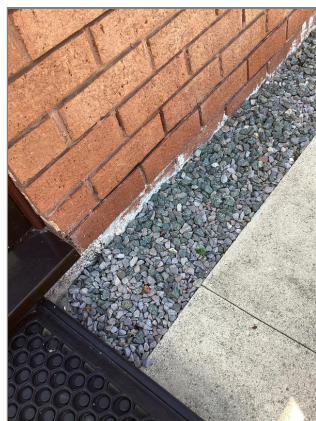
Some white staining can be seen to the property, particularly to the lower course of brickwork. This is normally caused by efflorescence (salt staining) and although unsightly is of no structural significance. It can normally be cleaned off but may return.

Photo - 2 Efflorescence to wall

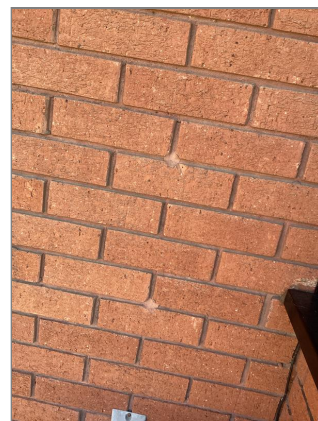
We understand that cavity wall insulation has been retrospectively installed to the property, made obvious by the small filled holes to the walls. Ask your legal adviser to check whether Local Authority notifications, approvals and completion certificates have been obtained, if necessary, for:

Photo - 3 Cavity insulation drill holes

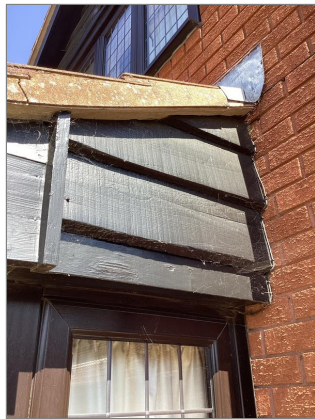
The joinery appeared to be in adequate condition from ground level. Ongoing maintenance will be required to resolve slight deterioration and other minor defects, and to prevent further deterioration. It is possible that some deterioration could be identified on closer inspection, for example wet rot behind the guttering.

*Photo - 4 Slightly weathered joinery*

External timbers at eaves level require regular maintenance to help prevent against rot.

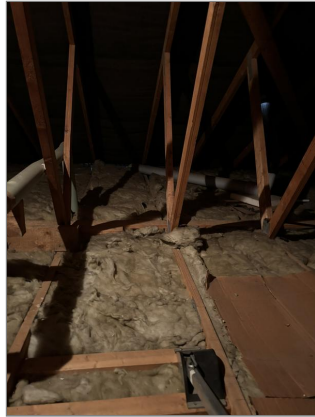
Insulation is present in the roof void, although this amount is considered inadequate by modern day standards. We recommend a minimum thickness of 300mm of fibreglass quilt or similar insulating material is provided over all areas with the exception of the eaves, below cold water storage and expansion tanks and around electrical cabling, which should be kept clear. The insulation should be increased as soon as possible to reduce heat loss from this property.

Photo - 5 Insulation minimal

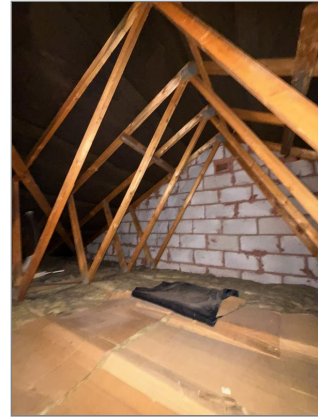
The roof structure is otherwise in satisfactory condition. The visible roofing felt also appeared to be in a reasonable condition. The roof structure is of typical design for a property of this age and type and timbers appear to be of adequate size and spacings to carry normal loads likely to be imposed upon them. The loft should only be used, if at all, for light storage and most importantly none of the timbers should be cut as this could considerably reduce the structural strength.

Photo - 6 Roof space

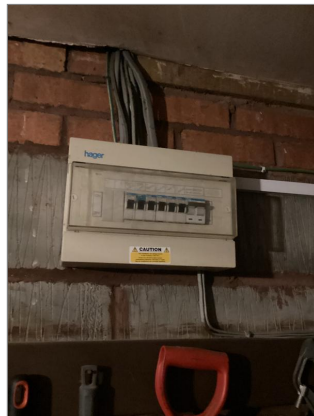
Photo - 11 Consumer unit

recently undertaken, it is recommended that the installation be tested by a competent electrician (NICEIC/ECA registered) prior to exchange of contracts to confirm its safe operation and so that you are aware of any likely future costs. All recommendations should be implemented. Thereafter, the installation should be re-tested as recommended by the electrician. However, we would strongly recommend an inspection of the electrical system on change of ownership regardless.

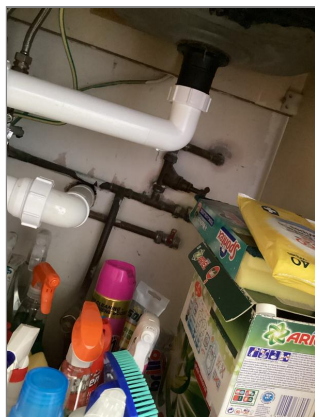
Photo - 12 Stopcock

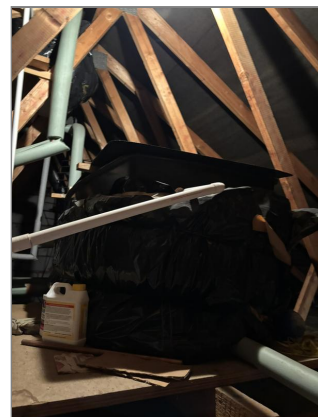
Photo - 13 Water tank

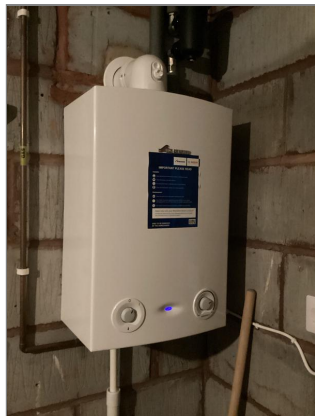
Photo - 14 Boiler

If there has been no inspection or test within the last 12 months then an inspection and service/safety test of all heating appliances must be carried out before use.

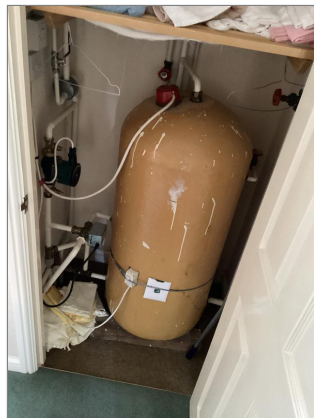
*Photo - 15 Hot water cylinder*

If there has been no inspection or test within the last 12 months then an inspection and service/safety test of all heating appliances must be carried out before use.

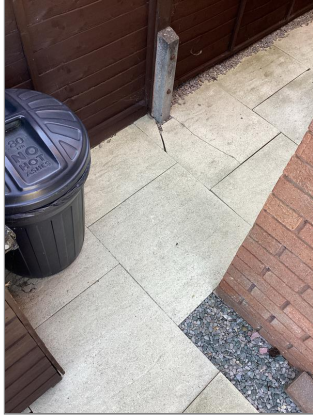
*Photo - 16 Cracked and uneven paving*
