# Your survey report

THIS IS A SAMPLE REPORT

9th February 2026

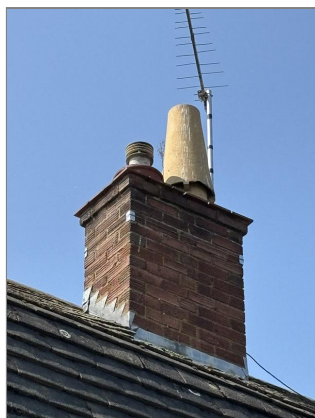
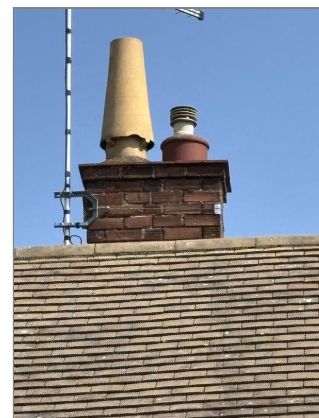
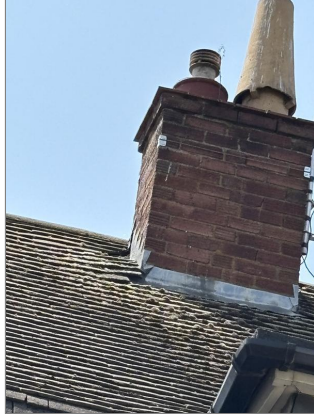
The mortar pointing is worn in places, and is loosening where the lead flashing meets the stack. Some roof tiles around the stack are broken, and this may allow water ingress internally and result in leakage to the stack. The stack requires some repointing, with the flashing resecured and thoroughly checked beneath the damaged tiles. The following repairs are required:

The stack otherwise appears in generally satisfactory condition with no signs of any significant defects, although shows some signs of weathering and exposure. Some general repointing works are likely to be required as part of annual maintenance works once the stack is inspected closely.

- the chimney stack requires repair, repointing and the flashing resecured.

The works identified should be undertaken as soon as practicably possible, and you are advised to get quotations from reputable and suitably qualified contractors prior to exchange of contracts. When remedial works are undertaken it would also be prudent to check the condition of all hidden parts in order to ensure that no further disrepair has taken place. As the work will mean some general disturbance to the building, further disrepair may also be uncovered which will increase costs. Until the repairs are undertaken, you should undertake regular internal checks for any signs of water ingress. Any pots which serve redundant flues ideally should now be capped in order to prevent any possible water penetration.

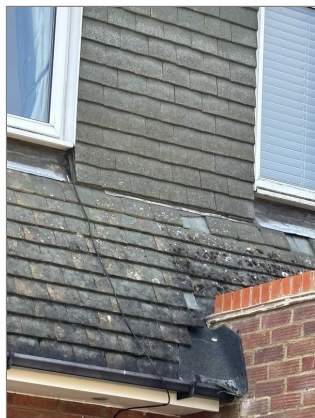
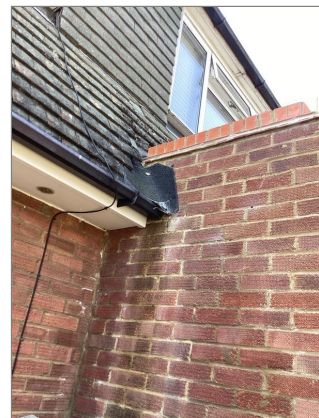
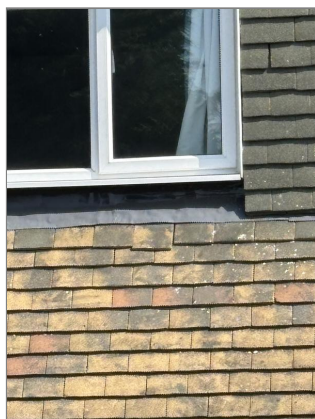
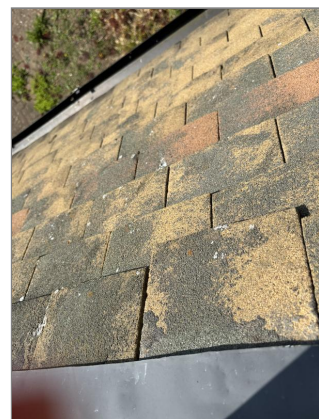
It appears the tiles have previously been pressure washed. This has removed the protective surface layer, leaving the tiles more porous and prone to deterioration. We noted areas where the tile faces are beginning to break down, and although the roof remains serviceable at present, the effects of erosion are accelerating, and the tiles are starting to deteriorate at the edges. There are several broken and slipped tiles, especially around the chimney stack on the rear elevation, which may allow water ingress. The mortar pointing to ridge tiles has come loose in places, and ongoing weathering will reduce the life expectancy of the covering further. The concrete tiles are likely to be original to the property. They have a tendency to become worn and more brittle with age and typically have a life expectancy of approximately 60 years and so it is likely that full renewal will soon be required. This is a risk to the building:

- defective and damaged coverings.

The felt lining is torn in places internally, and if tiles slip, there is no secondary protection to prevent the roof from leaking. The felt has also perished at the edges of the roof line. Roofing felt can become brittle with age, particularly when exposed to sunlight, rainwater and wind action, and deterioration often occurs along the lower leading edges of the roof.

There is a section of tiling on the rear which has been removed between the two properties to allow for the neighbouring extension to be built. This has been sealed with a piece of felt, but the felt has not been secured to the neighbouring wall, and this will allow water to penetrate behind the felt and potentially into the property. The detailing is poor and not considered a suitable long-term solution. We recommend that this junction is properly weatherproofed with appropriate flashings or leadwork by a competent roofing contractor to prevent water ingress and associated damp issues.

We recommend obtaining quotes from reputable roofing contractors for full replacement of the coverings and an anticipated timescale of when this should be undertaken, along with temporary repairs to any slipped or damaged tiles in the meantime to help reduce the risk of water ingress until full renewal can be undertaken. Repairs to roof areas and other high level elements will usually require the use of scaffolding. This will significantly increase repair costs and must be allowed for in any quotations for works. We recommend that further advice is obtained in the following area:

- obtain advice on the repairs required in the interim, and the cost of the replacement roof that will soon be required.

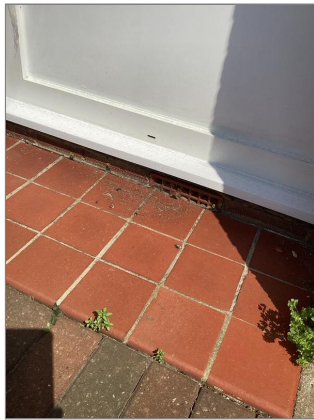
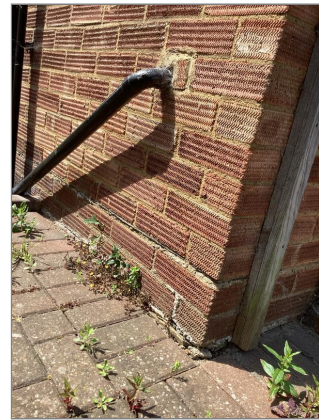
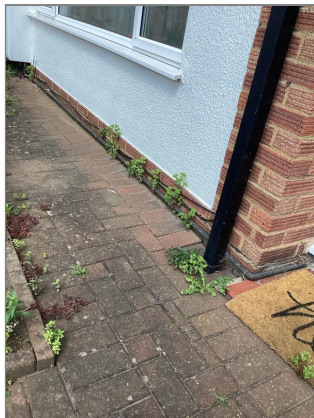
External ground levels were noted to be high in one or two positions which can lead to bridging of the DPC and sub-floor vents and dampness internally. Although no signs of dampness were noted from this, ideally, the DPC should be 150mm above the external ground level and where possible, external ground levels should be reduced as a precaution. The following repairs should be undertaken:

The walls appeared in generally satisfactory condition with no signs of any serious defects or structural defects noted although there are the expected signs of generally weathering and exposure. They appeared relatively plumb within accepted tolerances and the mortar pointing was also in acceptable condition. 'Spalling' (the breakdown by the action of frost and water) of the brickwork was noted to some of the lower bricks in places, and some individual bricks may need to be cut out and replaced.

The rendered finishes appear in generally satisfactory condition, although do show signs of some general exposure. Some minor hairline cracks are to be expected and are the result of some general shrinkage of the material and can be addressed when the property is next redecorated externally. Cement based render is particularly affected by expansion and contraction brought about by changes in temperature. It is a strong and waterproof material but it is also very brittle and continued heating and cooling will cause thermal cracking to the surface. Whilst not of any structural significance if allowed to develop this will allow water to penetrate in behind the surface of the render. If any moisture behind the cement freezes, the expanding ice can cause the cement to separate from the underlying masonry and this will cause the render to become loose and fall off. Therefore, the cement render should be kept in good condition and any cracks either raked out and repointed or filled with a flexible masonry paint or sealant as part of routine annual maintenance.

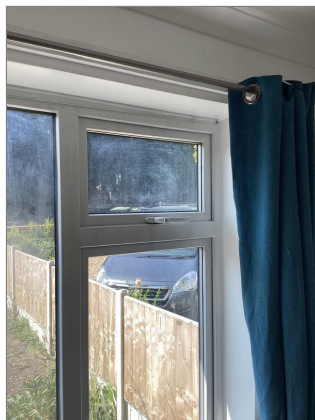
Photo - 11

Misting was noted to many of the double glazed units, and this would suggest that the seals have failed. Over time double glazing seals can perish and fail, allowing moisture to form between the panes which eventually leads to misting on the inside of the glass. The presence of such moisture often depends on certain atmospheric conditions and therefore this problem cannot always be seen on a single visit.

- blown glazing should be replaced, the window joinery requires some repair and stuck windows should be eased or replaced.

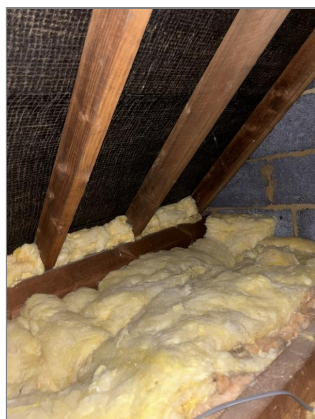
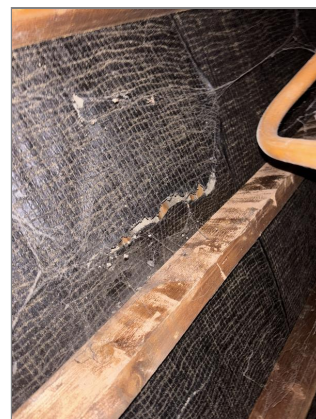
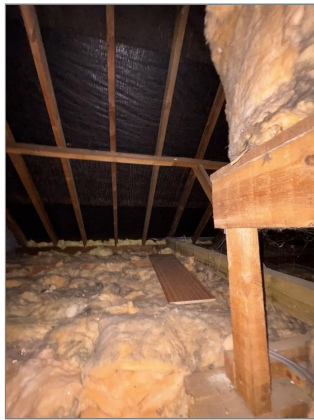
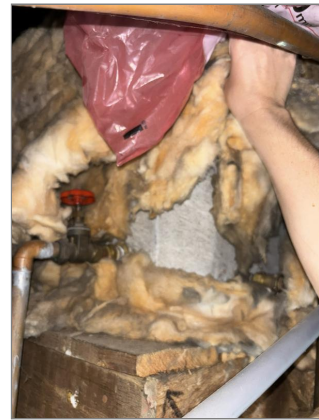
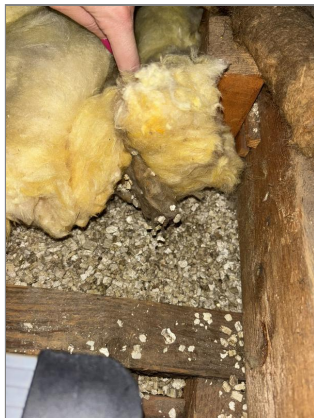
- unsafe loft ladder.

Water is stored in an asbestos cement tank located within the roof void. The tank appears to be generally well supported and are suitably covered and insulated. There is also a suitable overflow provision in place. We refer you to our comments in F3: Water regarding the tank.

E1: Roof structure - improvements to the insulation levels and ventilation arrangements, patch repairs to the roofing felt if deemed necessary, and replacement of the loft ladder.

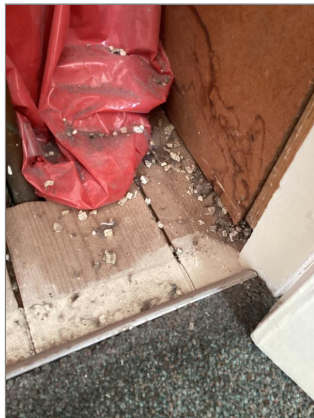
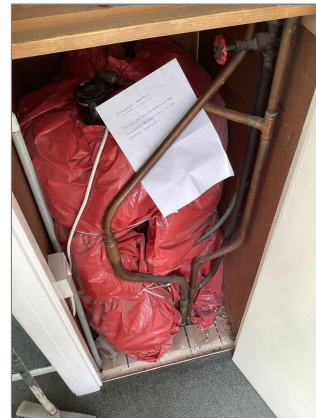
There is vermiculite insulation in the airing cupboard and we refer you to our comments in E1: Roof Coverings.

- instruct a competent contractor to carry out an inspection of the entire hot water installation, including the cylinder and associated pipework, and carry out repairs or replacement as appropriate.
