watsons

Building Survey

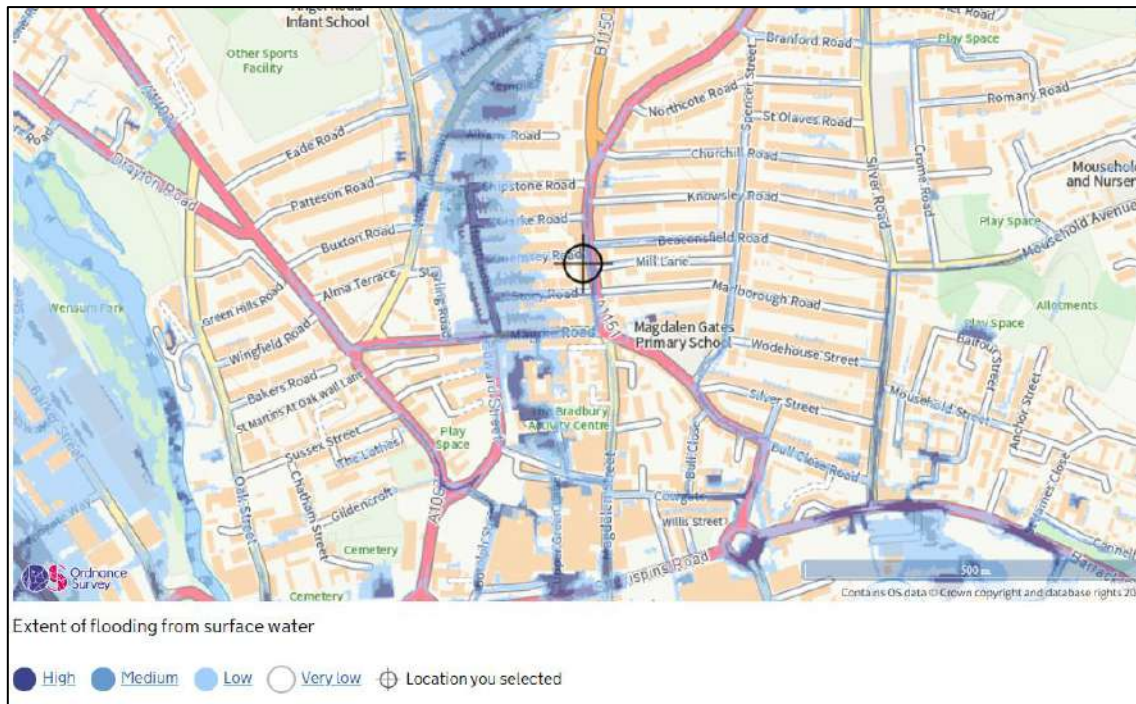
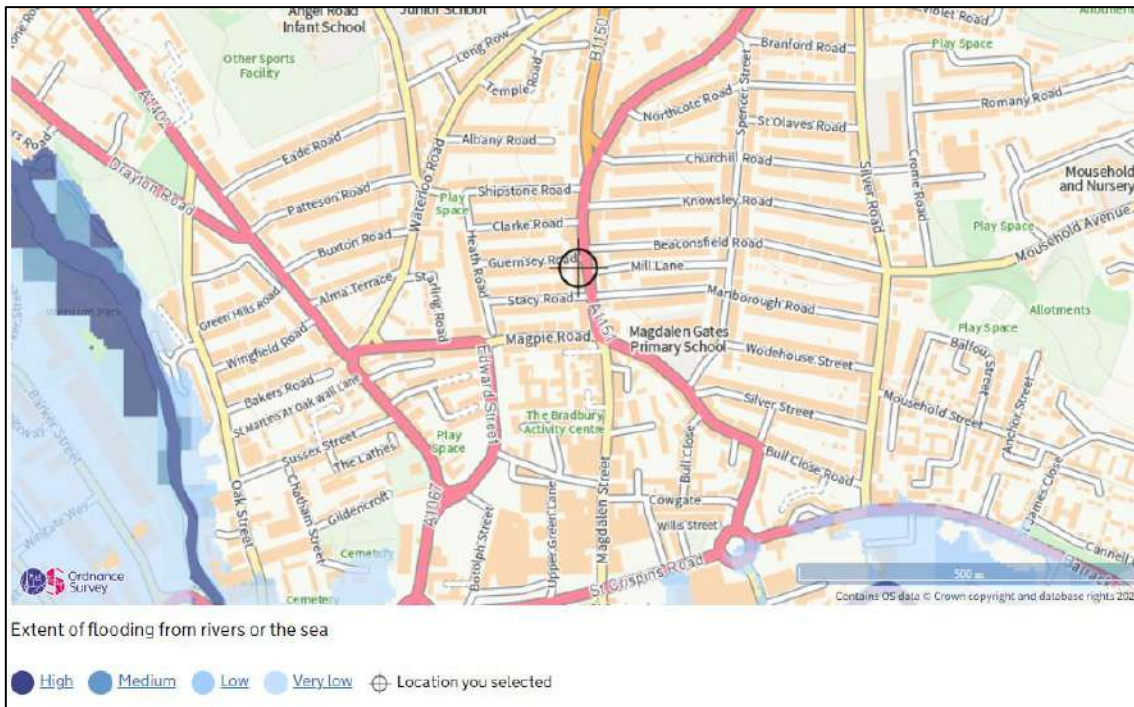
According to the Environment Agency (the Government organisation responsible for flood control) the site is located within an area that is of medium risk of flooding from surface water and very low risk of flooding from rivers and the sea.

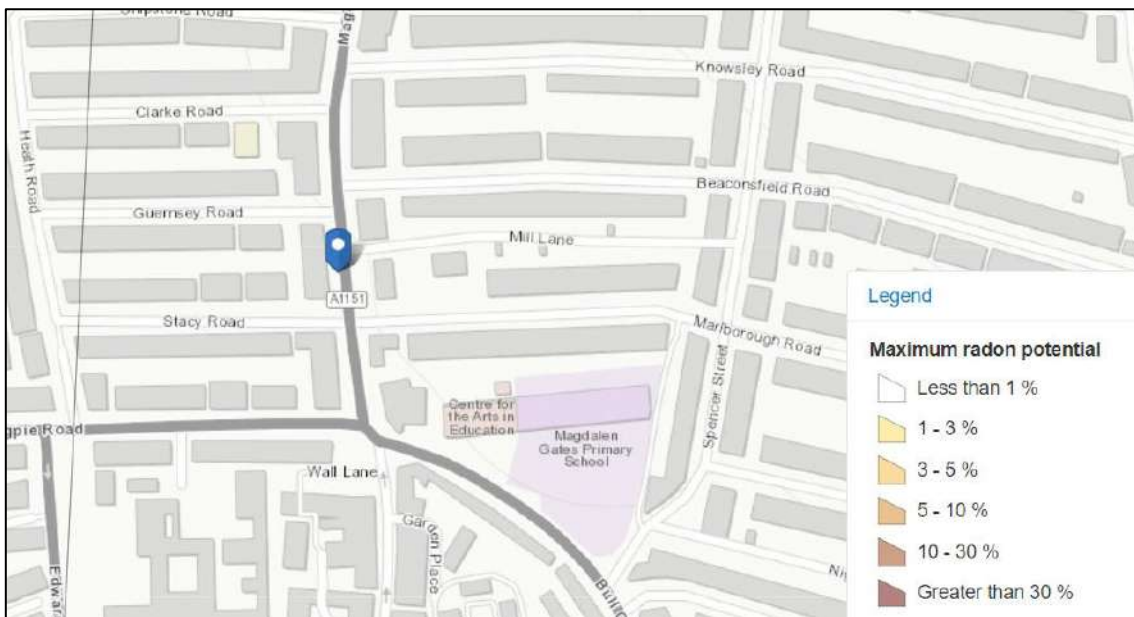
An online Radon search has been carried out and according to Public Health England, the probability of properties in this area being above the Action Level is 0 – 1%.

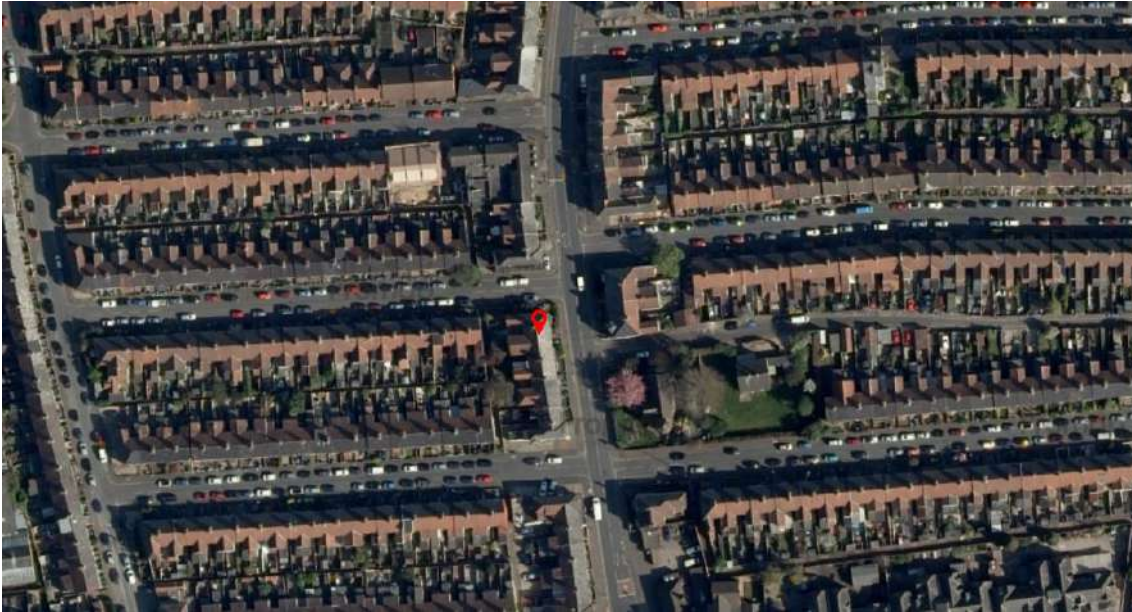
The front of the property would appear to face very approximately east.

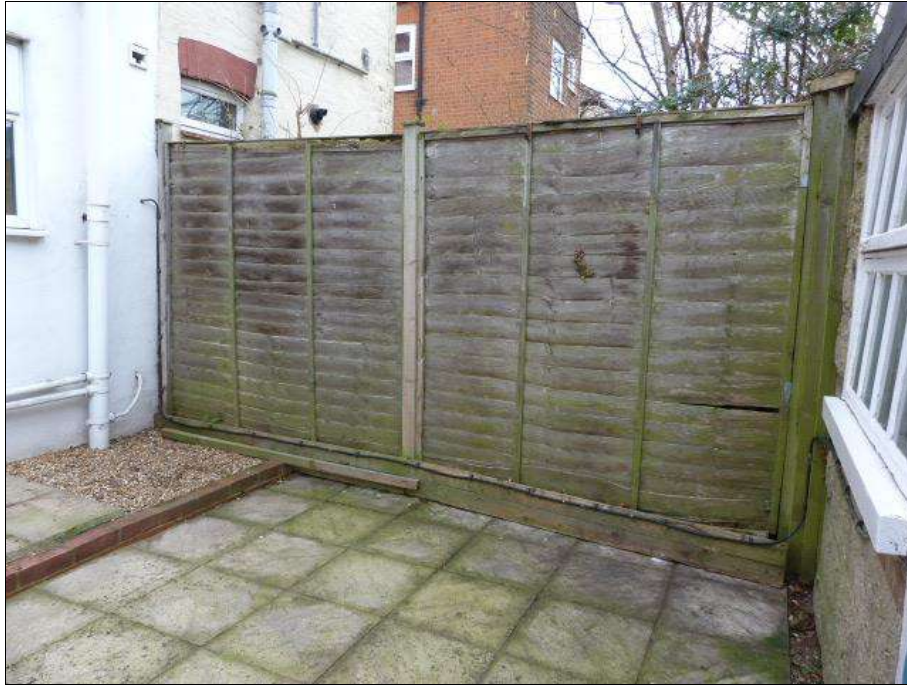
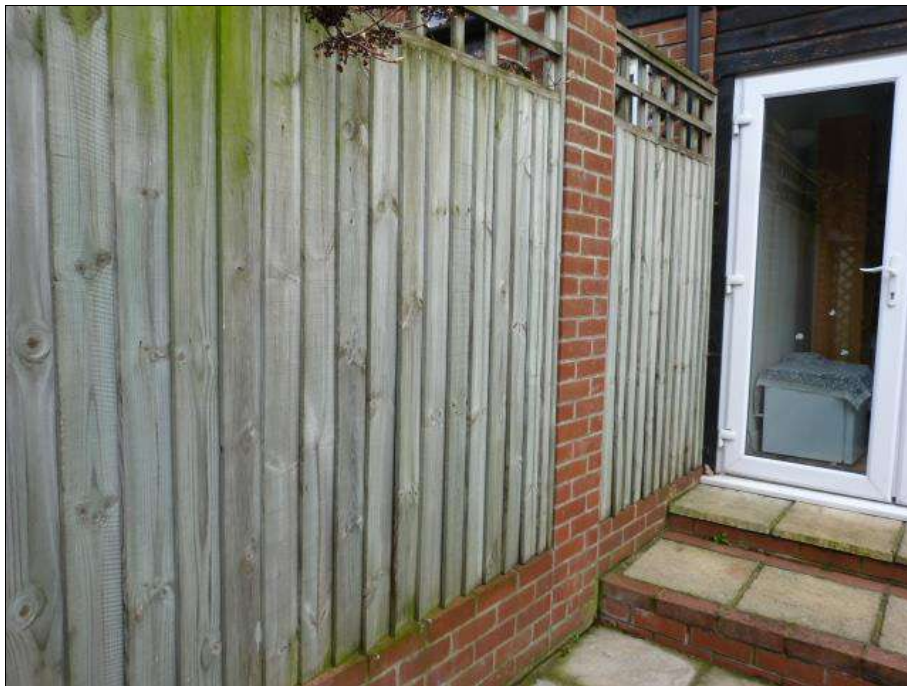
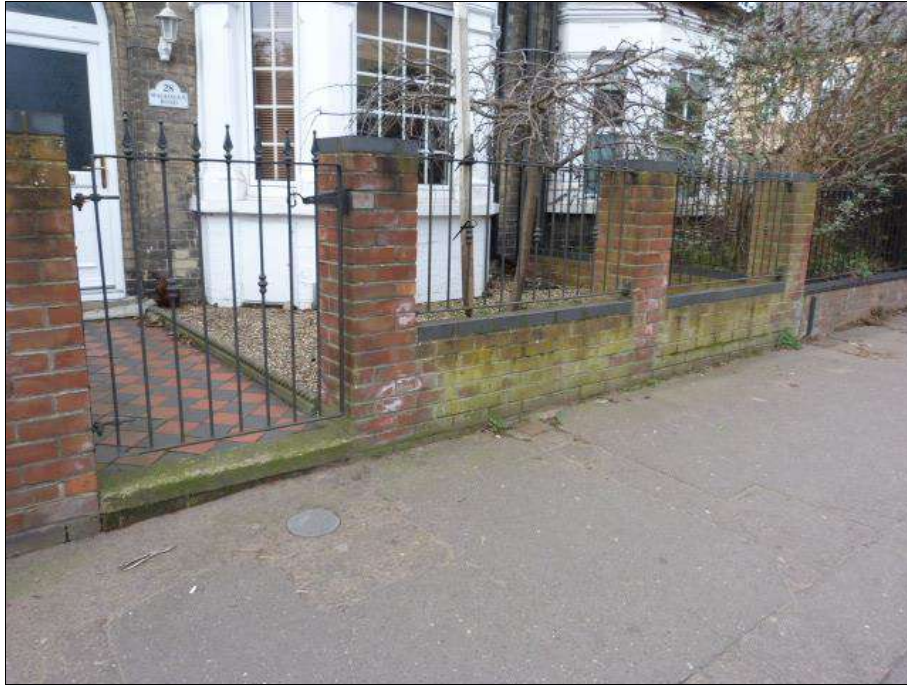
The boundaries of the site are reasonably well defined and comprise of timber panelled fencing either side to the rear, whilst to the front there are brick piers and wrought iron railings. Your Solicitor should confirm ownership and therefore repairing liabilities.
