watsons

LEVEL 2

# Your survey report

1st July 2025

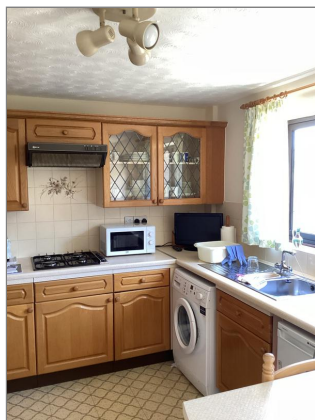
Photo - 7

All seals to kitchen fittings should be maintained in a good condition to prevent the penetration of water and the associated risks to adjacent timbers.

Kitchens can be particularly prone to condensation and mould growth. To help prevent this, a balance between background heating, insulation and permanent ventilation is required. Mechanical ventilation is recommended in kitchens, although additional measures may be necessary following specialist advice. The mechanical vents should be cleaned regularly.

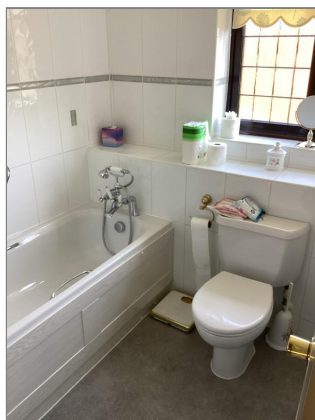
Photo - 8

No extractor fans have been fitted in the bathrooms. Bathrooms are particularly prone to condensation and mould growth. To help prevent this, a balance between background heating, insulation and permanent ventilation is required. Mechanical ventilation is recommended in bathrooms, although additional measures may be necessary following specialist advice. The mechanical vents should be cleaned regularly.

The general condition of the sanitary fittings was satisfactory. All seals to sanitary fittings should be maintained in a good condition to prevent the penetration of water and the associated risks to adjacent timbers.

Showers generate significant amounts of steam which will in turn cause condensation. Even with a good mechanical ventilation system mould can be problematic and you will need to remain vigilant and take action at its onset.
