# Your survey report

THIS IS A SAMPLE REPORT

9th February 2026

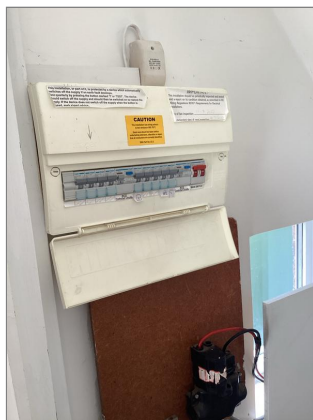
Photo - 18

(NICEIC/ECA registered) prior to exchange of contracts to confirm its safe operation and so that you are aware of any likely future costs. All recommendations should be implemented. Thereafter, the installation should be re-tested as recommended by the electrician. However, we would strongly recommend an inspection of the electrical system on change of ownership regardless.

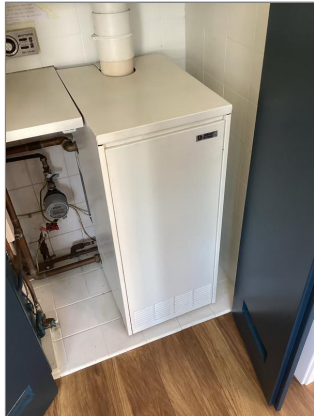
Photo - 21

Central heating is provided by means of a gas fired condensing boiler located in the kitchen cupboard serving radiators within the property. The pipework serving the heating system is of copper. The boiler has been replaced within the current vendors ownership in 2023. We are not aware of any service documentation, and if a boiler is not regularly serviced after installation, the warranty may then be void.

At the time of the inspection the central heating was turned on. Within the limitations of our inspection, it appeared to operate satisfactorily. However, without a specialist report from a heating engineer it is not possible to say whether the system is completely effective or functions satisfactorily. Our limited inspection of the system revealed no evidence to suggest any serious defects, but we would nevertheless recommend that a test and overhaul of the installation be undertaken prior to purchase and that a regular maintenance contract be placed with an approved heating engineer.

If there has been no inspection or test within the last 12 months then an inspection and service/safety test of all heating appliances must be carried out before use. If the boiler has not been regularly serviced, then the guarantee may be invalid, and your legal adviser should confirm that a service record exists.

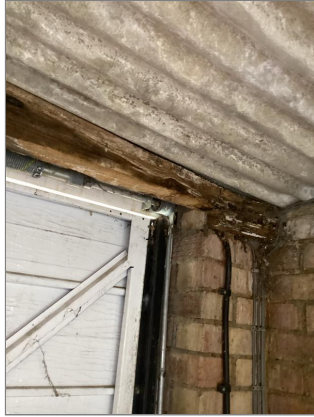
*Photo - 24*

Garages are often built on shallower footings than those of the main building and as a result can

be more prone to the effects of structural movement. You should make sure that your electrician checks any electrics within the garage as part of our earlier recommendations.
